Grays Harbor College

2018 Facility Master Plan

March 2018

KMB architects

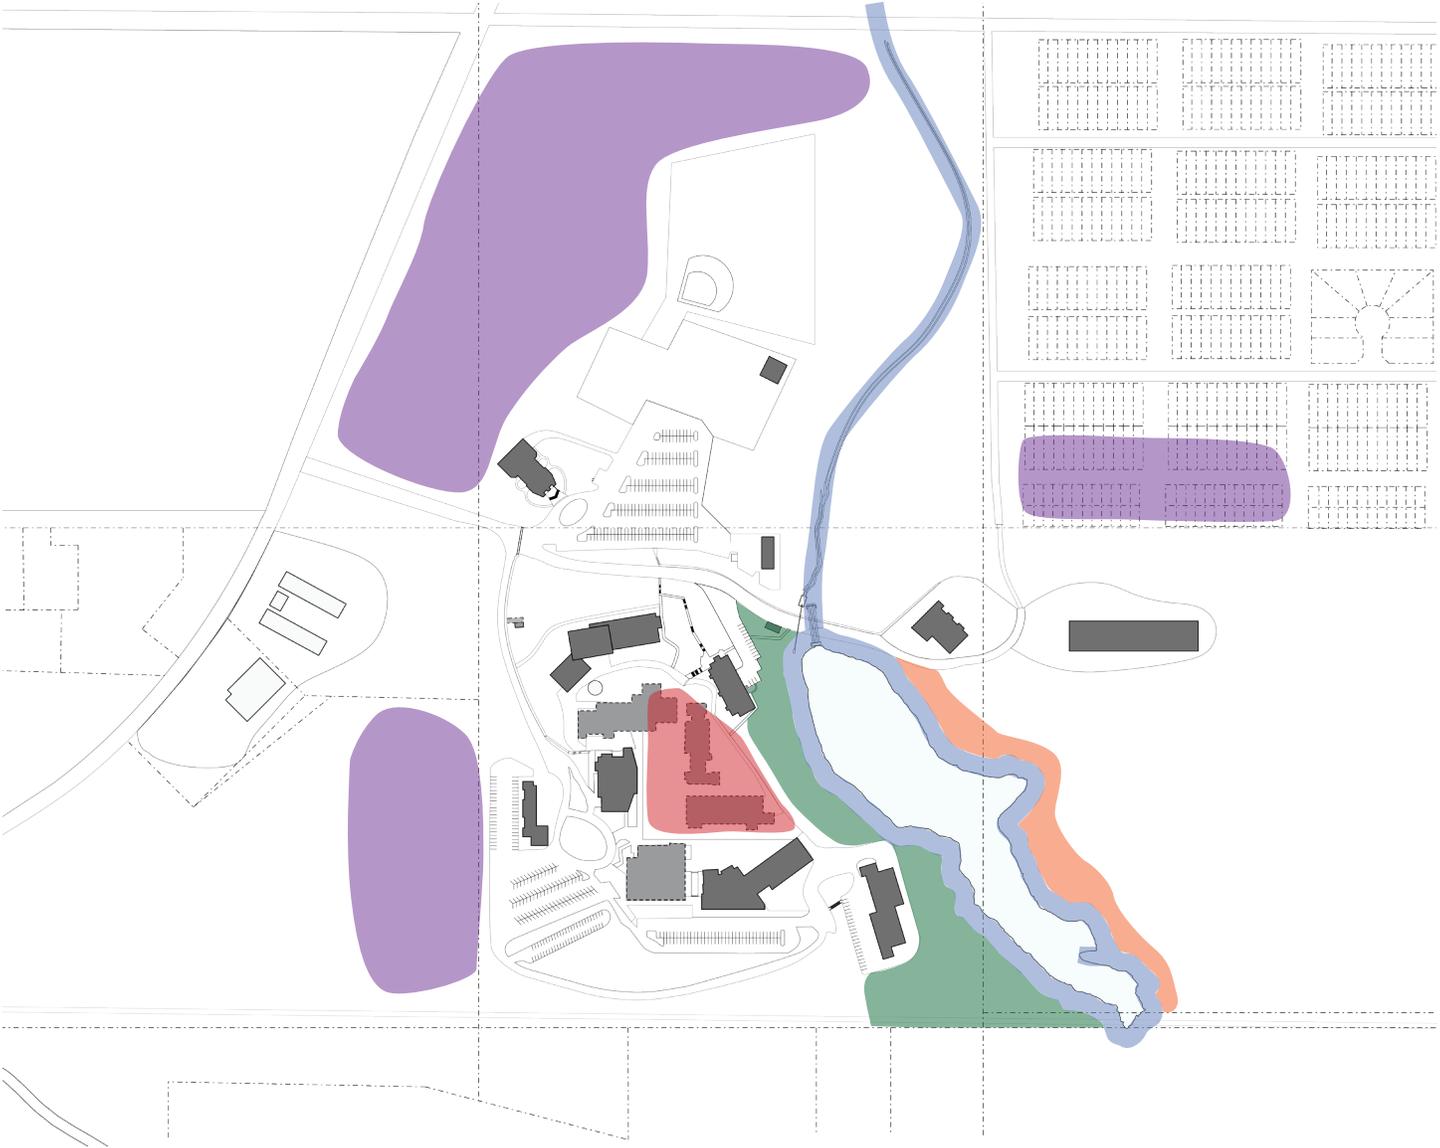
5.01 Land Use and Environmental

Grays Harbor College is lucky to be located next to Lake Swano and Alder Creek, both salmon bearing bodies of water. The land surrounding the water needs to be protected for the salmon thus there are setbacks and protected wetlands adjacent to them. The area between the campus and the lake is very steep and may be costly to construct on and may have possible impacts to the lake. Avoiding construction on the steep slopes by the lake is recommended.

- 100 ft setback- Salmon bearing
- Persevered Wetland
- Steep Slope
- Possible Future Development Sites

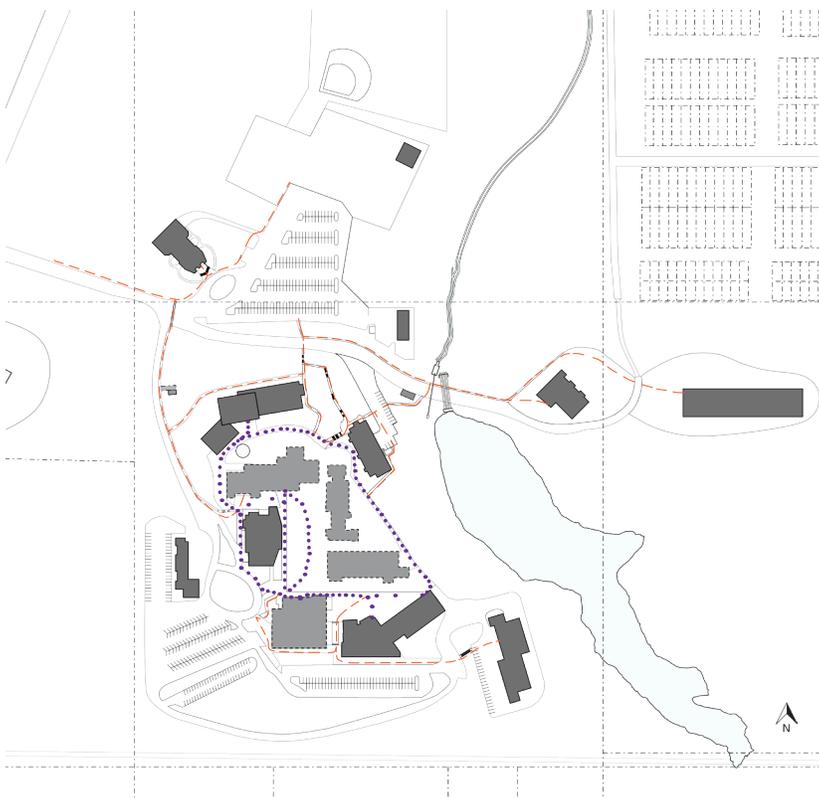
5.05 Transit Access

Students that live within the city limits of Aberdeen can use public transit to reach campus. Two bus lines come to the campus for students. The 55 line does not enter campus but students can be dropped off on Boone street just outside of College property. The 10B line does access the main campus for students. This line currently has two stops on campus near the Schermer Building (building 4000) and John Spellman Library (building 1500). Updates to the bus stop locations on the site are recommended. For students that live outside Aberdeen there is a number 14 bus line that runs from Raymond to Aberdeen and Grays Harbor College three times a day. This line makes one stop on campus at the John Spellman Library.

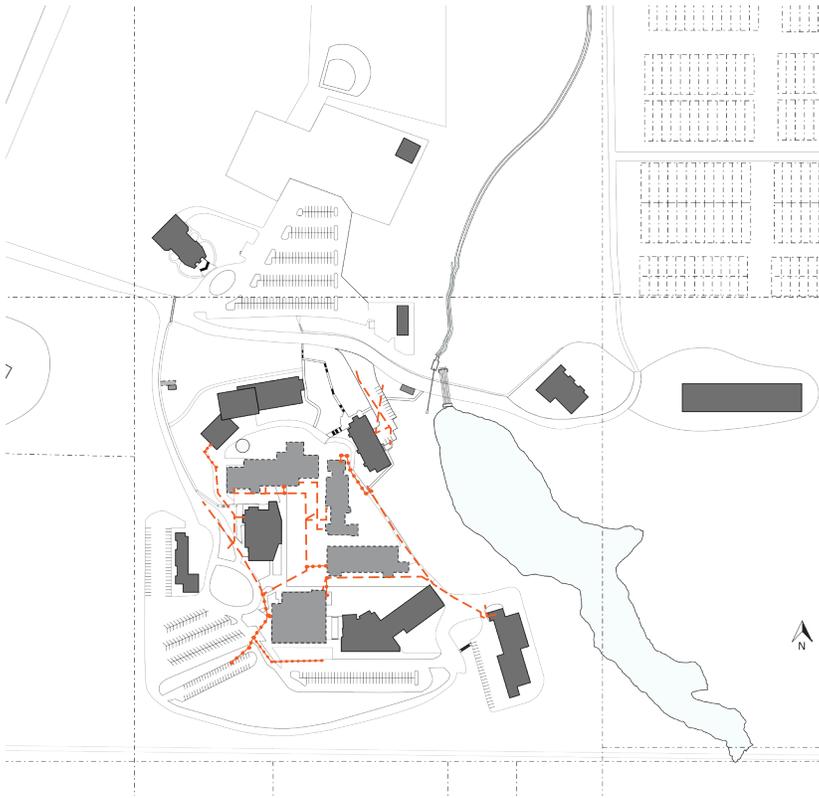
5.09 Utilities - Waterlines

Water is located throughout the campus at each building. The water location are underground and have not shown signs of needing to be repaired.

- Known Waterline
- Estimated Water Lines

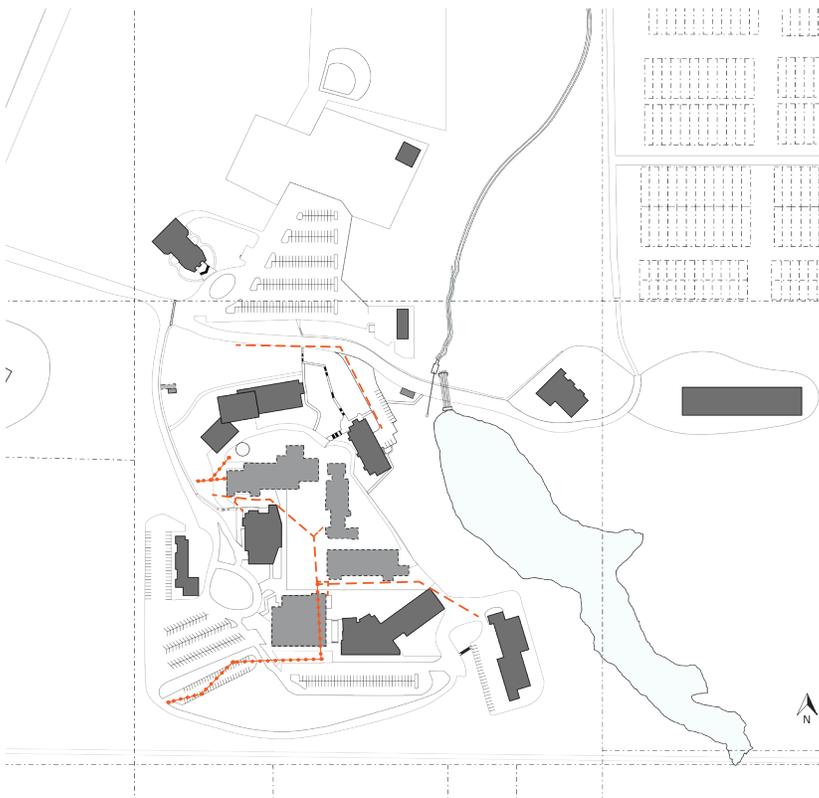
5.10 Utilities - Sanitary Lines

There is a concern about the age of the sanitary lines on campus since most of them are older than 50 years. The lines that are the oldest should be replaced which is estimates at being about 1,100 linear feet of pipe.

- 57 year old system
- 1,100 Linear Feet of pipe to be replaced
- Estimated Cost: \$600,000

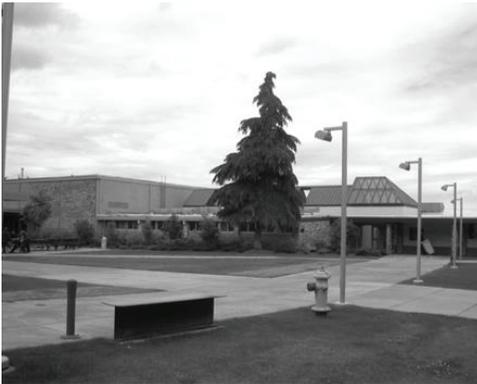
1. 100 Building, The Hiller Union Building

Area: 22,643 SF
 Built: 1957
 Remodeled: 1994
 Use: Student Center
 Construction: Medium
 CVR/SF: \$313
 Value: \$7,087,259

Previous Score: 306
Current Score: 313 - Needs Improvement/Additional Maintenance

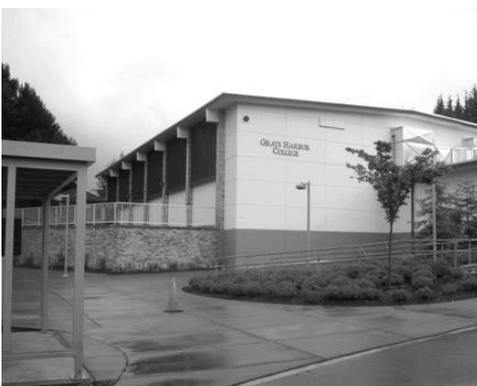
2. 500 Building, Gymnasium

Area: 18,814 SF
 Built: 1957
 Remodeled: 2001
 Use: Gymnasium
 Construction: Medium
 CVR/SF: \$279
 Value: \$5,249,106

Previous Score: 332
Current Score: 352 - Needs Improvement/Renovation

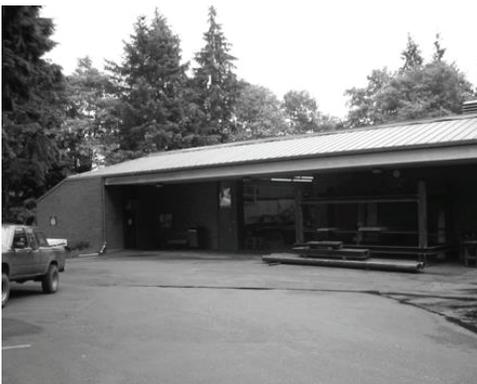
3. 700 Building, Voch/Tech

Area: 23,305 SF
 Built: 1971
 Remodeled: 2010
 Use: Vocational Arts
 Construction: Medium
 CVR/SF: \$316
 Value: \$7,364,380

Previous Score: 246
Current Score: 246 - Adequate

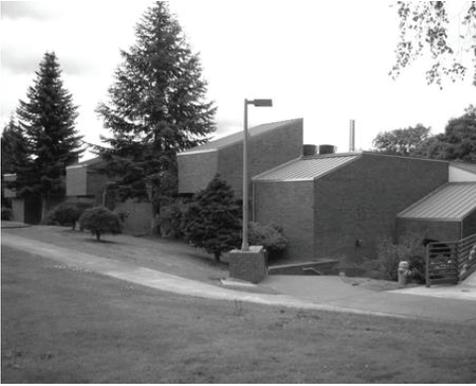
4. 800 Building, Instructional

Area: 18,238 SF
 Built: 1971
 Remodeled: No
 Use: Science Lab
 Construction: Heavy
 CVR/SF: \$391
 Value: \$7,131,058

Previous Score: 360
Current Score: 360 - Needs Improvement/Renovation

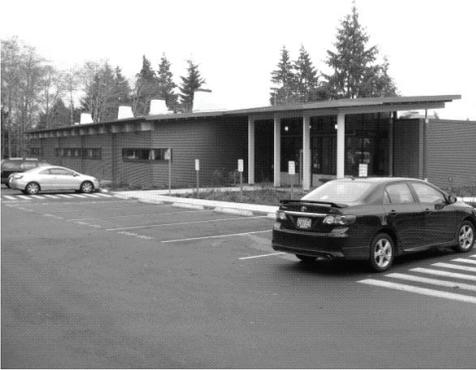
5. 1400 Building, Wunderland Daycare

Area: 6,246 SF
 Built: 2010
 Remodeled: No
 Use: Child Care
 Construction: Medium
 CVR/SF: \$290
 Value: \$1,811,340

Previous Score: 146
Current Score: 146 - Superior

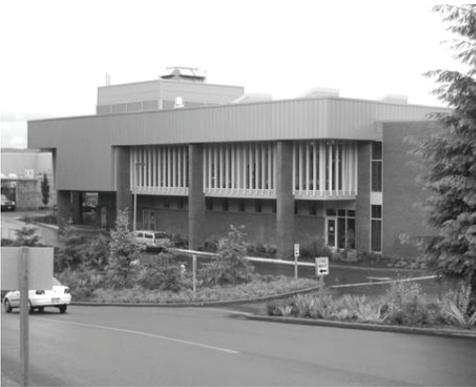
6. 1500 Building, The John Spellman Library

Area: 25,155 SF
 Built: 1966
 Remodeled: 2003
 Use: Library
 Construction: Medium
 CVR/SF: \$301
 Value: \$7,571,655

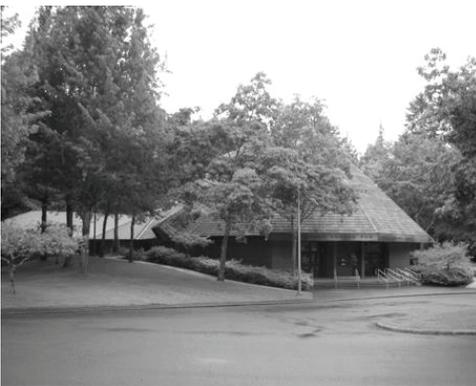
Previous Score: 170
Current Score: 170 - Superior

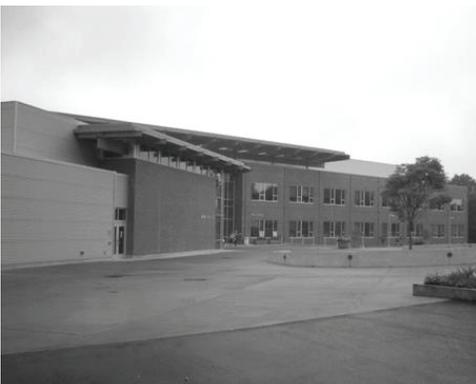
10. 1900 Building, Automotive/Welding

Area: 21,750 SF
 Built: 2007
 Remodeled: No
 Use: Vocational Arts
 Construction: Medium
 CVR/SF: \$316
 Value: \$6,773,000

Previous Score: 158
Current Score: 159- Superior

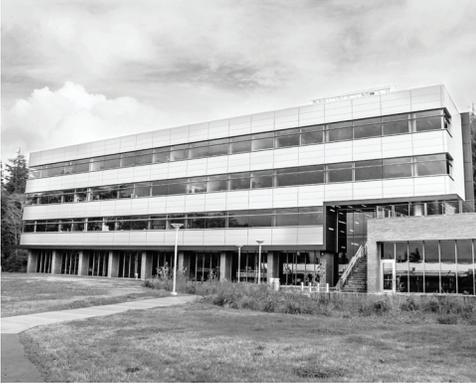
11. 2000 Building, Manspeaker Instructional Building

Area: 71,755 SF
 Built: 2007
 Remodeled: No
 Use: General Classroom
 Construction: Heavy
 CVR/SF: \$301
 Value: \$21,598,255

Previous Score: 170
Current Score: 170 - Superior

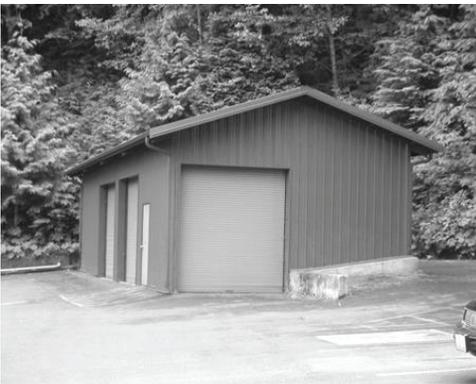
13. Sand Shed

Area: 1,945 SF
 Built: 2010
 Remodeled: No
 Use: Storage
 Construction: Light
 CVR/SF: \$43
 Value: \$83,635

Previous Score: 242
Current Score: 265 - Adequate

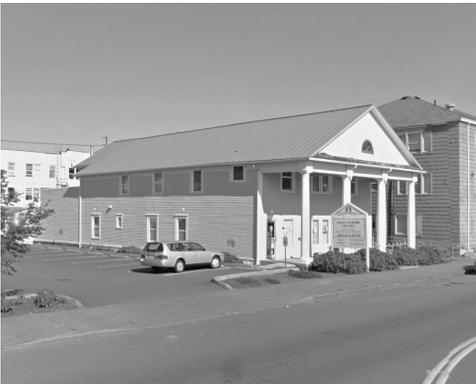
16. Whiteside Education Center

Area: 5,396 SF
 Built: 1919
 Remodeled: 1997
 Use: Mixed Use
 Construction: Light
 CVR/SF: \$316
 Value: \$1,705,136

Previous Score: 278
Current Score: 278 - Needs Improvement/Additional Maintenance

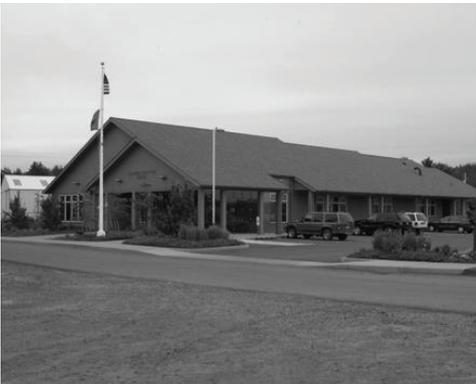
17. Columbia Education Center

Area: 6,342 SF
 Built: 2006
 Remodeled: No
 Use: Multi-Use
 Construction: Medium
 CVR/SF: \$290
 Value: \$1,839,180

Previous Score: 178
Current Score: 179 - Adequate

Primary Systems	
COMPONENT: Structure	RATING: 1 x WEIGHT: 8.3 = SCORE: 8.3
No signs of settlement or cracking, no abrupt vertical changes Columns, bearing walls and roof structure appears sound/free of defects	
COMMENTS: Wood frame; concrete foundation	
COMPONENT: Exterior Closure	RATING: 1 x WEIGHT: 8.3 = SCORE: 8.3
Weatherproof, tight, well-maintained exterior walls, doors, windows/finishes	
COMMENTS: Cement board lap siding; wood shingles; plywood soffits; glass wind screens	
COMPONENT: Roofing	RATING: 1 x WEIGHT: 10.4 = SCORE: 10.4
Flashing and penetrations appear sound and membrane appears water-tight; drainage is positive and there are overflow scuppers	
COMMENTS: Composition 3-tab shingles

Secondary Systems			
COMPONENT:	Floor Finishes	RATING: 3 x WEIGHT: 6.3 =	SCORE: 18.8
Some wear and minor imperfections are evident; beginning deterioration			
COMMENTS:	Colored concrete and carpet-surface wear		
COMPONENT:	Wall Finishes	RATING: 1 x WEIGHT: 6.3 =	SCORE: 6.3
Maintainable surfaces in good condition			
COMMENTS:	Gypsum board; recycled vertical T&G wood; ceramic tile		
COMPONENT:	Ceiling Finishes	RATING: 1 x WEIGHT: 6.3 =	SCORE: 6.3
Maintainable surfaces in good condition; good alignment and appearance			
COMMENTS:	Gypsum board and direct-adhered tile		
COMPONENT:	Doors & Hardware	RATING: 1 x WEIGHT: 6.3 =	SCORE: 6.3
Appropriate hardware, closers, panic devices; in good working order			
COMMENTS:	Interior/exterior wood doors/frames

Service Systems			
COMPONENT:	Elevators	RATING: 0 x WEIGHT: 0 =	SCORE: 0
No data			
COMMENTS:			
COMPONENT:	Plumbing	RATING: 1 x WEIGHT: 8.3 =	SCORE: 8.3
Fixtures and piping appear to be in good condition; no evidence of leaks			
COMMENTS:	Copper, ABS and PVC piping; porcelain fixtures		
COMPONENT:	HVAC	RATING: 1 x WEIGHT: 8.3 =	SCORE: 8.3
Equipment in good condition; easily controlled; serves all required spaces; All necessary spaces are adequately ventilated; A/C provided			
COMMENTS:	Horizontal electric forced air furnaces w cooling coils and outside condensers		
COMPONENT:	Electrical	RATING: 1 x WEIGHT: 8.3 =	SCORE: 8.3
Adequate service and distribution capacity for current/future needs			
COMMENTS:	600amp 208/120v		
COMPONENT:	Lights/Power	RATING: 1 x WEIGHT: 8.3 =	SCORE: 8.3
Contemporary lighting with good work area illumination; ample outlets			
COMMENTS:	Lay-in, hanging and ceiling mount strip fluorescent lights

Safety Systems		
COMPONENT:	Life/Safety	RATING: 1 x WEIGHT: 10.4 = SCORE: 10.4
Appears to meet current codes		
COMMENTS:		
COMPONENT:	Fire Safety	RATING: 3 x WEIGHT: 10.4 = SCORE: 31.3
Extinguishers and signed egress; no violations; no alarm or sprinklers		
COMMENTS:		
COMPONENT:	Modifications	RATING: 1 x WEIGHT: 7.3 = SCORE: 7.3
Modifications appear to be in compliance with codes and sound construction practices; HVAC/electrical service properly provided		
COMMENTS:	None evident

Quality Standards		
COMPONENT:	Maintenance	RATING: 1 x WEIGHT: 7.3 = SCORE: 7.3
Facility appears well maintained		
COMMENTS:		
COMPONENT:	Remaining Life	RATING: 1 x WEIGHT: 6.3 = SCORE: 6.3
Life expectancy is >15 years; minor system deterioration		
COMMENTS:		
COMPONENT:	Appearance	RATING: 1 x WEIGHT: 6.3 = SCORE: 6.3
Well-constructed building; generally attractive interior and exterior		
COMMENTS:	Well-designed wood structure; use of recycled wood on inside enhances interior

TOTAL SCORE = 179 PREVIOUS BIENNIUM SCORE = 178
 CONDITION: Adequate

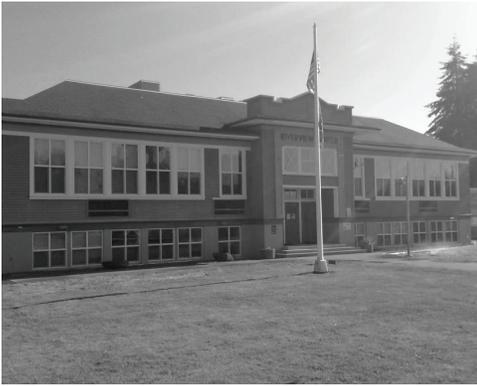
18. Riverview Education Center

Area: 12,660 SF
 Built: 1925
 Remodeled: 2001
 Use: General Classroom
 Construction: Medium
 CVR/SF: \$301
 Value: \$3,810,660

Previous Score: 182
Current Score: 198 - Adequate

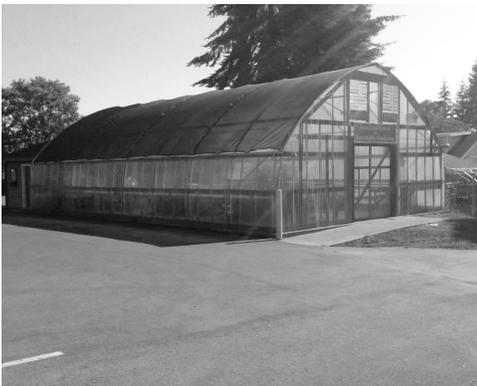
19. Leon Lead Green House

Area: 1,824 SF
 Built: 2009
 Remodeled: No
 Use: Classroom
 Construction: No Data
 CVR/SF: \$285
 Value: \$519,840

Previous Score: 182
Current Score: 198 - Adequate

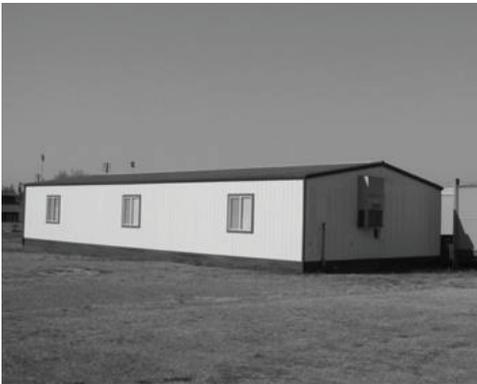
20. Simpson Education Center

Area: 1,792 SF
 Built: 1998
 Remodeled: No
 Use: General Classroom
 Construction: Temporary
 CVR/SF: \$185
 Value: \$331,520

Previous Score: 354
Current Score: 366 - Needs Improvement/Renovation

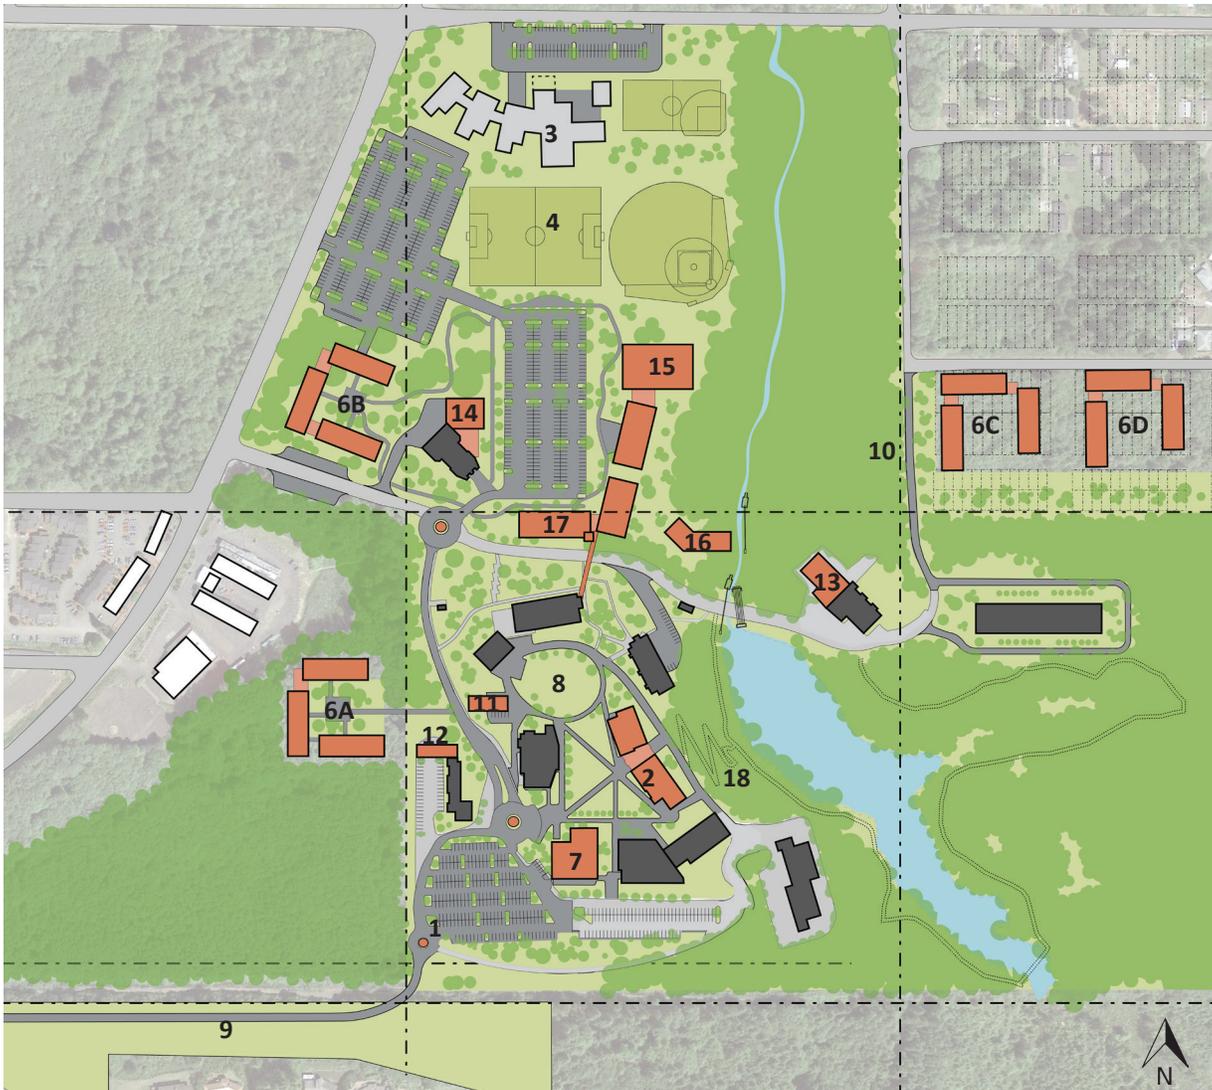
Proposed Campus Accessibility Updates:

The designation of an additional egress road that connects Grays Harbor College's upper campus to Highway 105 creates an additional emergency exit and improves campus traffic circulation. A third access road could be re-developed to the north of the diesel tech building.

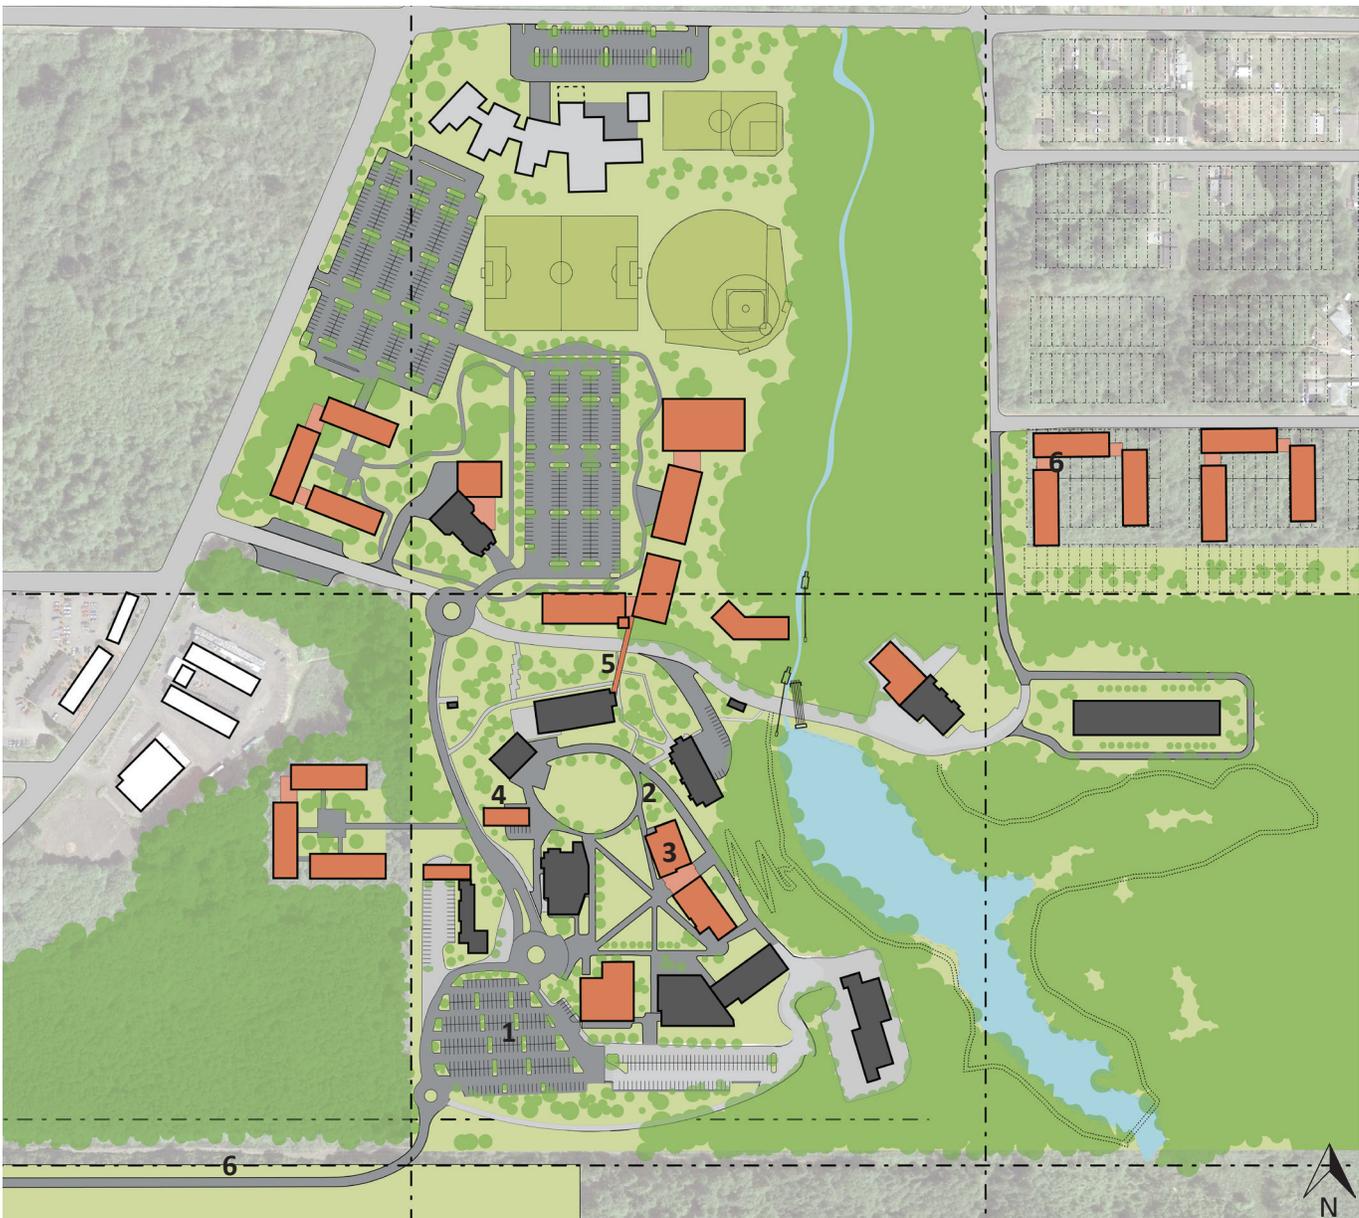
8.2 Masterplan

KMB architects and opsis architecture worked with Grays Harbor College stakeholders to project growth among campus facilities based on predicted needs. Buildings identified with pink coloring represent future facility sites, while buildings colored with white indicate existing and non-campus infrastructure.

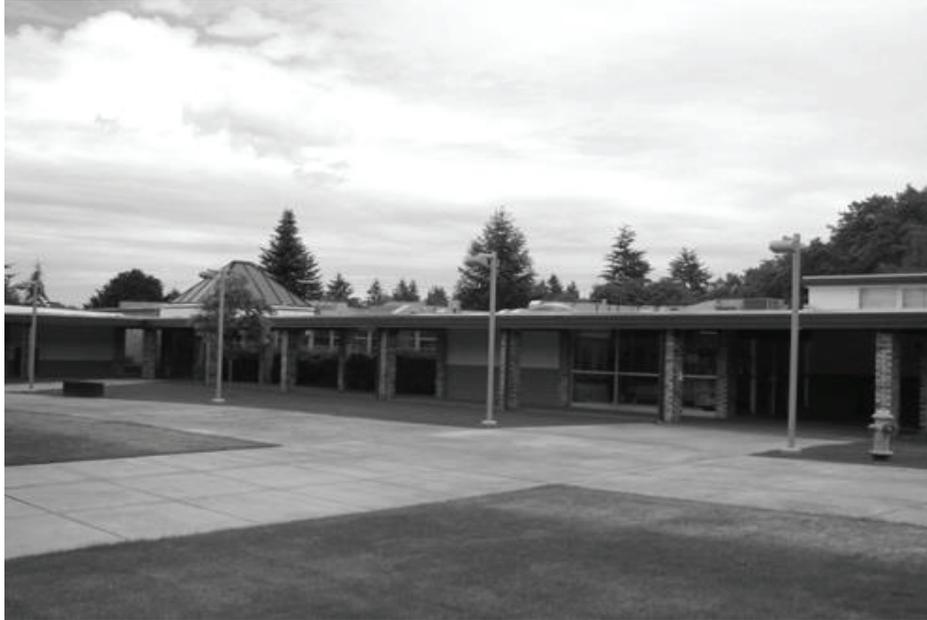
Admin (020-2) STATE UFI: A00079 Main Campus (020A)
 AREA: 12,437 SF BUILT: 1957 REMODELED: 1996 PREDOMINANT USE: Administration
 CONSTRUCTION TYPE: Medium CRV/SF: \$269 REPLACEMENT VALUE: \$3,345,553

Primary Systems	
COMPONENT:	Structure RATING: 3 x WEIGHT: 8.3 = SCORE: 25
Some cracking evident but does not likely affect structural integrity; Visible defects apparent but are non-structural	
COMMENTS: Cast concrete; wood framing	
COMPONENT:	Exterior Closure RATING: 3 x WEIGHT: 8.3 = SCORE: 25
Sound and weatherproof but with some deterioration evident	
COMMENTS: Concrete; brick; marblecrete	
COMPONENT:	Roofing RATING: 3 x WEIGHT: 10.4 = SCORE: 31.3
Some deterioration is evident in membrane and flashings; maintenance or minor repair is needed	
COMMENTS: BUR w/ UV coat; significant wear of UV coating - funded 2013-15; skylight

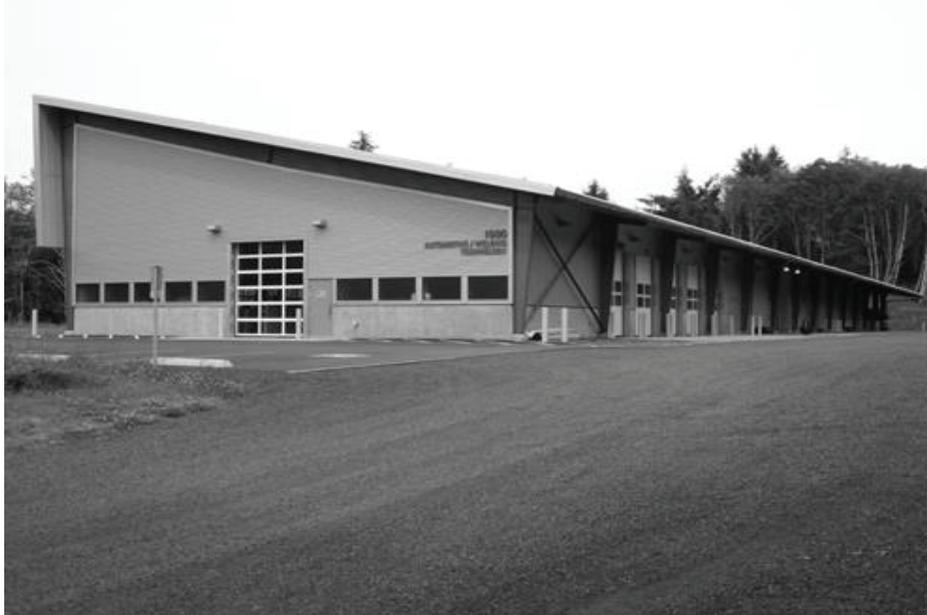
Auto/Weld Technology (020-19) STATE UFI: A05800 Main Campus (020A)
 AREA: 21,750 SF BUILT: 2007 REMODELED: No PREDOMINANT USE: Vocational Arts
 CONSTRUCTION TYPE: Medium CRV/SF: \$316 REPLACEMENT VALUE: \$6,873,000

Primary Systems	
COMPONENT: Structure	RATING: 1 x WEIGHT: 8.3 = SCORE: 8.3
No signs of settlement or cracking, no abrupt vertical changes Columns, bearing walls and roof structure appears sound/free of defects	
COMMENTS: Steel frame	
COMPONENT: Exterior Closure	RATING: 1 x WEIGHT: 8.3 = SCORE: 8.3
Weatherproof, tight, well-maintained exterior walls, doors, windows/finishes	
COMMENTS: Standing seam metal panels; corrugated metal panels; concrete	
COMPONENT: Roofing	RATING: 1 x WEIGHT: 10.4 = SCORE: 10.4
Flashing and penetrations appear sound and membrane appears water- tight; drainage is positive and there are overflow scuppers	
COMMENTS: Standing seam metal

CONDITION: Superior

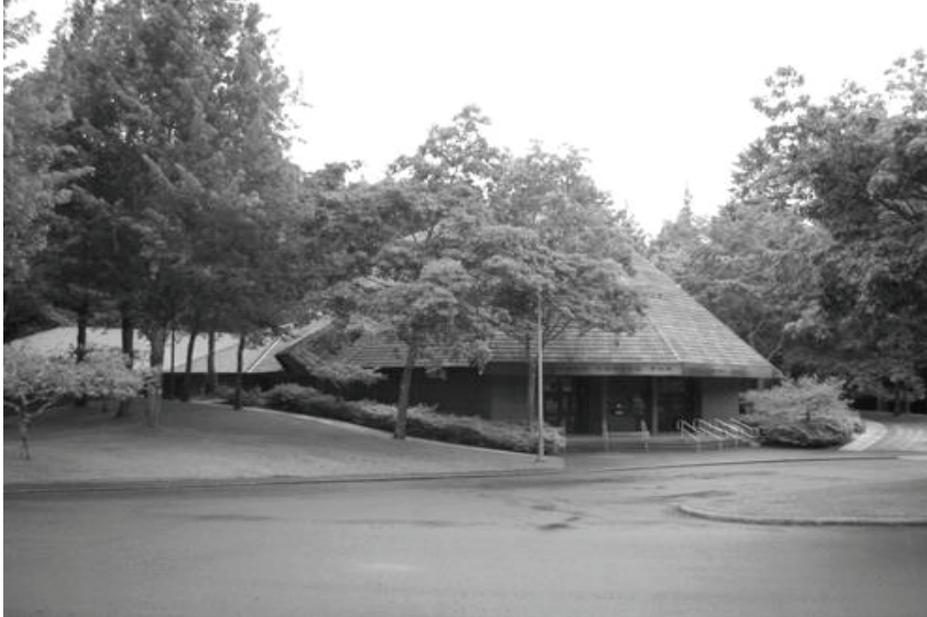
Bishop (020-16) STATE UFI: A05956 Main Campus (020A)
 AREA: 17,144 SF BUILT: 1974 REMODELED: No PREDOMINANT USE: Performing Arts
 CONSTRUCTION TYPE: Medium CRV/SF: \$337 REPLACEMENT VALUE: \$5,777,528

Primary Systems	
COMPONENT: Structure	RATING: 1 x WEIGHT: 8.3 = SCORE: 8.3
No signs of settlement or cracking, no abrupt vertical changes Columns, bearing walls and roof structure appears sound/free of defects	
COMMENTS: Wood framing; brick; some steel	
COMPONENT: Exterior Closure	RATING: 1 x WEIGHT: 8.3 = SCORE: 8.3
Weatherproof, tight, well-maintained exterior walls, doors, windows/finishes	
COMMENTS: Brick; plywood soffits; Hardi-board siding	
COMPONENT: Roofing	RATING: 1 x WEIGHT: 10.4 = SCORE: 10.4
Flashing and penetrations appear sound and membrane appears water- tight; drainage is positive and there are overflow scuppers	
COMMENTS: Significant portion of tile roof replaced in 2005; 3-tab composite shingles

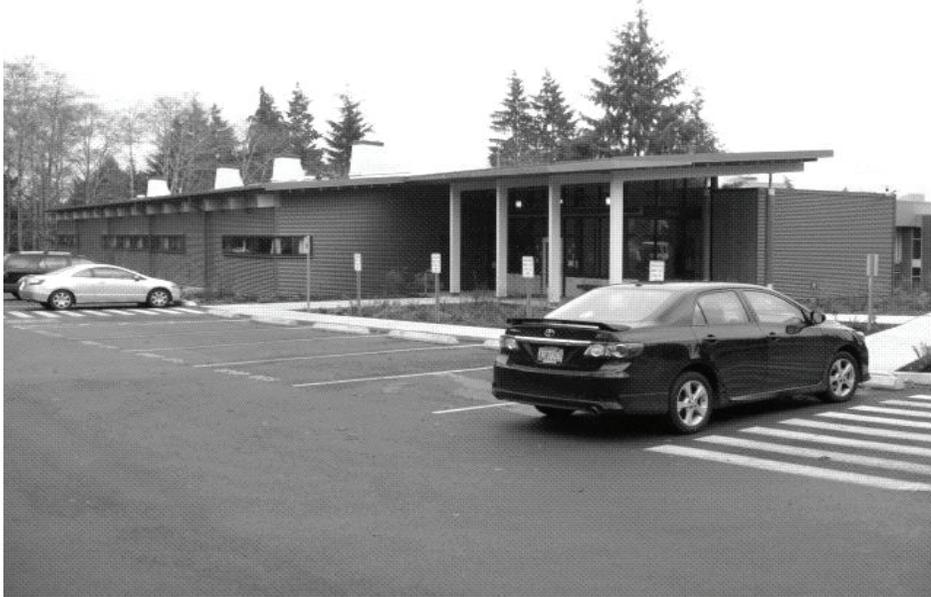
Child Care Center (020-14) STATE UFI: A07080 Main Campus (020A)
 AREA: 6,246 SF BUILT: 2010 REMODELED: No PREDOMINANT USE: Child Care
 CONSTRUCTION TYPE: Medium CRV/SF: \$290 REPLACEMENT VALUE: \$1,811,340

Primary Systems	
COMPONENT: Structure	RATING: 1 x WEIGHT: 8.3 = SCORE: 8.3
No signs of settlement or cracking, no abrupt vertical changes Columns, bearing walls and roof structure appears sound/free of defects	
COMMENTS: wood frame	
COMPONENT: Exterior Closure	RATING: 1 x WEIGHT: 8.3 = SCORE: 8.3
Weatherproof, tight, well-maintained exterior walls, doors, windows/finishes	
COMMENTS: Corrugated metal panels; vertical wood t&g; aluminum window walls	
COMPONENT: Roofing	RATING: 1 x WEIGHT: 10.4 = SCORE: 10.4
Flashing and penetrations appear sound and membrane appears water- tight; drainage is positive and there are overflow scuppers	
COMMENTS: TPO single-ply; temperature-controlled operable skylights

Secondary Systems			
COMPONENT:	Floor Finishes	RATING: 1 x	WEIGHT: 6.3 = SCORE: 6.3
Nice appearance, smooth transitions, level subfloors, no cracks/separating			
COMMENTS:	Concrete; ceramic tile; sheet vinyl		
COMPONENT:	Wall Finishes	RATING: 1 x	WEIGHT: 6.3 = SCORE: 6.3
Maintainable surfaces in good condition			
COMMENTS:	Vertical t&g cedar; concrete; laminate panels; gypsum board		
COMPONENT:	Ceiling Finishes	RATING: 1 x	WEIGHT: 6.3 = SCORE: 6.3
Maintainable surfaces in good condition; good alignment and appearance			
COMMENTS:	T&G cedar; gypsum board		
COMPONENT:	Doors & Hardware	RATING: 1 x	WEIGHT: 6.3 = SCORE: 6.3
Appropriate hardware, closers, panic devices; in good working order			
COMMENTS:	Interior wood doors/frames; exterior aluminum/HM doors/frames

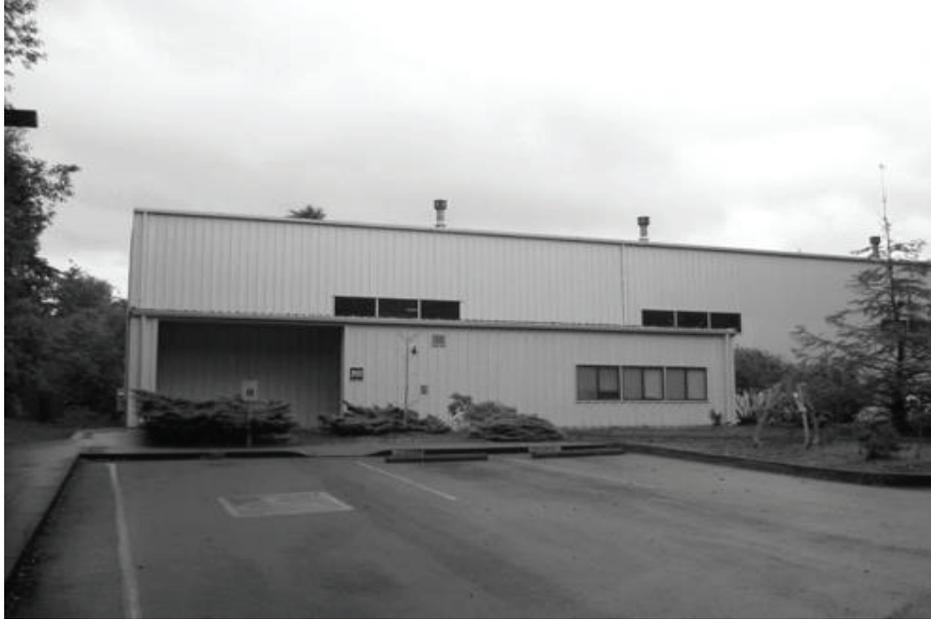
Heavy Equipment Shop (020-18) STATE UFI: A05882 Main Campus (020A)
 AREA: 9,484 SF BUILT: 1988 REMODELED: No PREDOMINANT USE: Vocational Arts
 CONSTRUCTION TYPE: Light CRV/SF: \$316 REPLACEMENT VALUE: \$2,996,944

Primary Systems	
COMPONENT: Structure	RATING: 1 x WEIGHT: 8.3 = SCORE: 8.3
No signs of settlement or cracking, no abrupt vertical changes Columns, bearing walls and roof structure appears sound/free of defects	
COMMENTS: Steel frame	
COMPONENT: Exterior Closure	RATING: 1 x WEIGHT: 8.3 = SCORE: 8.3
Weatherproof, tight, well-maintained exterior walls, doors, windows/finishes	
COMMENTS: Metal panels-painted in 2008	
COMPONENT: Roofing	RATING: 3 x WEIGHT: 10.4 = SCORE: 31.3
Some deterioration is evident in membrane and flashings; maintenance or minor repair is needed	
COMMENTS: Metal panel roof-coated in 2007; soffit leaks at entry

Secondary Systems			
COMPONENT:	Floor Finishes	RATING: 3 x WEIGHT: 6.3 =	SCORE: 18.8
Some wear and minor imperfections are evident; beginning deterioration			
COMMENTS:	Concrete-portion is coated with epoxy; flaking finish		
COMPONENT:	Wall Finishes	RATING: 3 x WEIGHT: 6.3 =	SCORE: 18.8
Aging surfaces but sound; some maintenance is required			
COMMENTS:	Gypsum board-scuffed/dinged; plywood; vinyl-clad insulation; laminate panels		
COMPONENT:	Ceiling Finishes	RATING: 1 x WEIGHT: 6.3 =	SCORE: 6.3
Maintainable surfaces in good condition; good alignment and appearance			
COMMENTS:	Lay-in tile; plywood; gypsum board; vinyl-clad insulation		
COMPONENT:	Doors & Hardware	RATING: 3 x WEIGHT: 6.3 =	SCORE: 18.8
Functional but dated			
COMMENTS:	Interior and exterior HM doors/frames; sectional metal OH doors; surface wear throughout

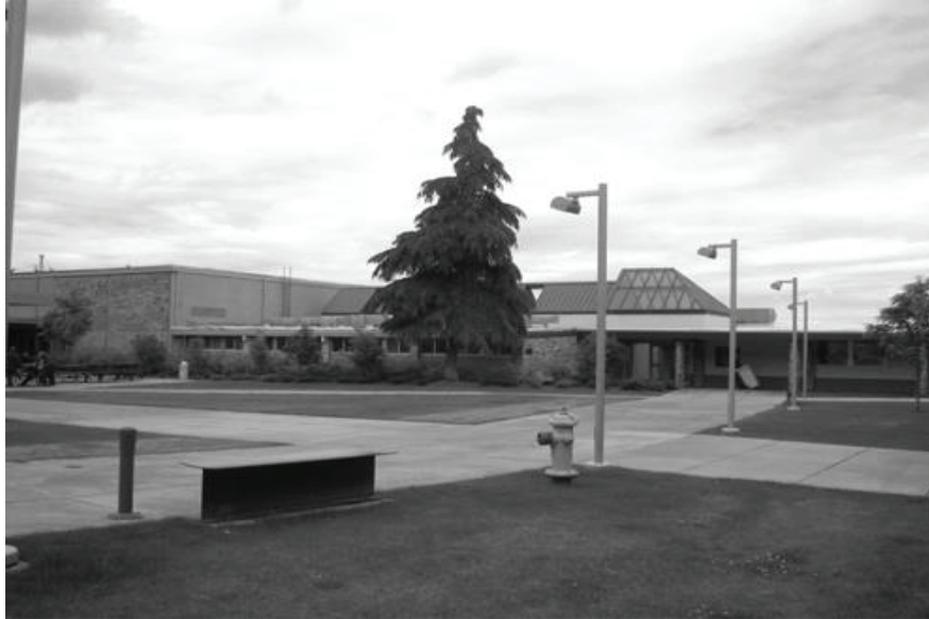
Hillier Union Building (020-1) STATE UFI: A00146 Main Campus (020A)
 AREA: 22,643 SF BUILT: 1957 REMODELED: 1994 PREDOMINANT USE: Student Center
 CONSTRUCTION TYPE: Medium CRV/SF: \$313 REPLACEMENT VALUE: \$7,087,259

Primary Systems	
COMPONENT: Structure	RATING: 3 x WEIGHT: 8.3 = SCORE: 25
Some cracking evident but does not likely affect structural integrity; Visible defects apparent but are non-structural	
COMMENTS: Cast concrete; wood framing; potential seismic issues	
COMPONENT: Exterior Closure	RATING: 3 x WEIGHT: 8.3 = SCORE: 25
Sound and weatherproof but with some deterioration evident	
COMMENTS: Concrete; brick; marblecrete; EIFS; wood soffits	
COMPONENT: Roofing	RATING: 1 x WEIGHT: 10.4 = SCORE: 10.4
Flashing and penetrations appear sound and membrane appears water-tight; drainage is positive and there are overflow scuppers	
COMMENTS: Single-ply hypalon-2003; skylights

Secondary Systems		
COMPONENT:	Floor Finishes	RATING: 1 x WEIGHT: 6.3 = SCORE: 6.3
Nice appearance, smooth transitions, level subfloors, no cracks/separating		
COMMENTS:	Concrete; quarry tile; brick; ceramic tile; sheet vinyl-carpet-surface wear; some 9x9 VAT	
COMPONENT:	Wall Finishes	RATING: 1 x WEIGHT: 6.3 = SCORE: 6.3
Maintainable surfaces in good condition		
COMMENTS:	Gypsum board; ceramic tile; wood strip; brick	
COMPONENT:	Ceiling Finishes	RATING: 1 x WEIGHT: 6.3 = SCORE: 6.3
Maintainable surfaces in good condition; good alignment and appearance		
COMMENTS:	Gypsum board; direct adhered tile; lay-in tile	
COMPONENT:	Doors & Hardware	RATING: 3 x WEIGHT: 6.3 = SCORE: 18.8
Functional but dated		
COMMENTS:	Interior wood doors w HM frames-surface wear; exterior aluminum/HM doors/frames

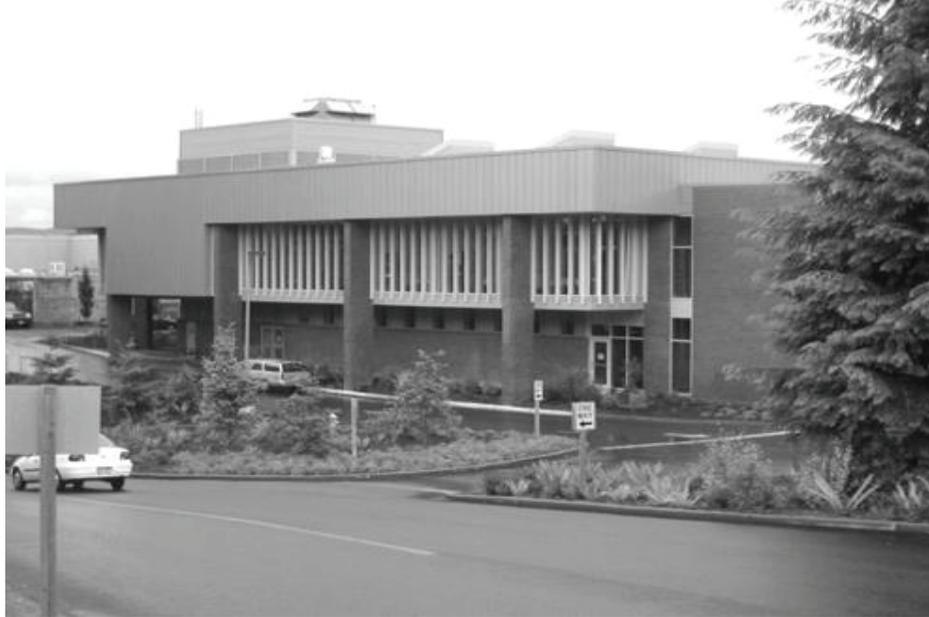
Lib (020-15) STATE UFI: A09264 Main Campus (020A)
 AREA: 25,155 SF BUILT: 1966 REMODELED: 2003 PREDOMINANT USE: Library
 CONSTRUCTION TYPE: Medium CRV/SF: \$301 REPLACEMENT VALUE: \$7,571,655

Primary Systems	
COMPONENT: Structure	RATING: 1 x WEIGHT: 8 = SCORE: 8
No signs of settlement or cracking, no abrupt vertical changes Columns, bearing walls and roof structure appears sound/free of defects	
COMMENTS: Wood; concrete	
COMPONENT: Exterior Closure	RATING: 1 x WEIGHT: 8 = SCORE: 8
Weatherproof, tight, well-maintained exterior walls, doors, windows/finishes	
COMMENTS: Concrete; brick; metal panels; aluminum window walls	
COMPONENT: Roofing	RATING: 1 x WEIGHT: 10 = SCORE: 10
Flashing and penetrations appear sound and membrane appears water- tight; drainage is positive and there are overflow scuppers	
COMMENTS: Hypalon single-ply membrane; skylights

Secondary Systems			
COMPONENT:	Floor Finishes	RATING: 3 x WEIGHT: 6 =	SCORE: 18
Some wear and minor imperfections are evident; beginning deterioration			
COMMENTS:	Carpet and vinyl tile-surface wear; slate tile; ceramic tile; cement		
COMPONENT:	Wall Finishes	RATING: 1 x WEIGHT: 6 =	SCORE: 6
Maintainable surfaces in good condition			
COMMENTS:	Gypsum board; wood; ceramic tile; brick		
COMPONENT:	Ceiling Finishes	RATING: 1 x WEIGHT: 6 =	SCORE: 6
Maintainable surfaces in good condition; good alignment and appearance			
COMMENTS:	Lay-in tile; gypsum board		
COMPONENT:	Doors & Hardware	RATING: 1 x WEIGHT: 6 =	SCORE: 6
Appropriate hardware, closers, panic devices; in good working order			
COMMENTS:	Interior wood doors w aluminum frames; sidelites; exterior aluminum doors/frames

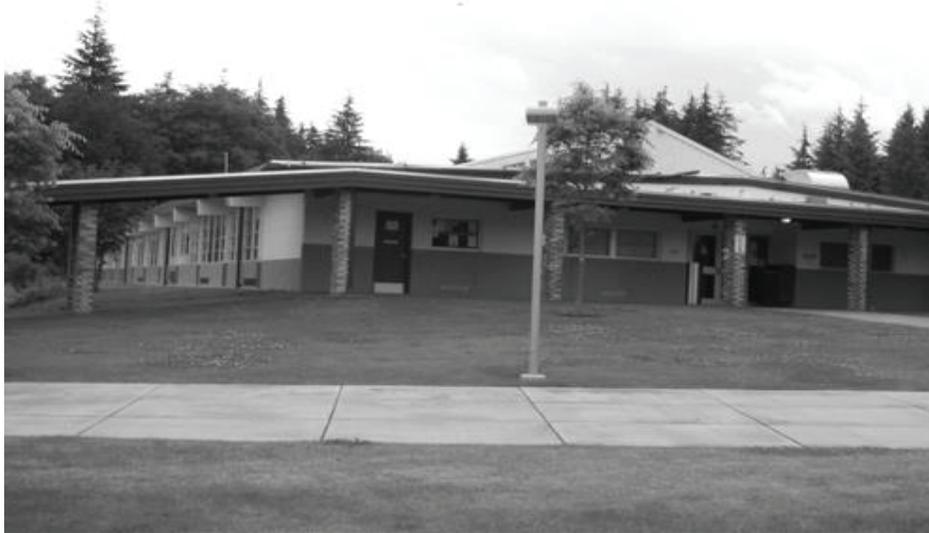
Lifsci (020-3) STATE UFI: A04995 Main Campus (020A)
 AREA: 14,767 SF BUILT: 1957 REMODELED: 1993 PREDOMINANT USE: General Classroom
 CONSTRUCTION TYPE: Medium CRV/SF: \$301 REPLACEMENT VALUE: \$4,444,867

Primary Systems	
COMPONENT: Structure	RATING: 3 x WEIGHT: 8.3 = SCORE: 25
Some cracking evident but does not likely affect structural integrity; Visible defects apparent but are non-structural	
COMMENTS: Cast concrete; wood framing - WILL DEMO 2015	
COMPONENT: Exterior Closure	RATING: 3 x WEIGHT: 8.3 = SCORE: 25
Sound and weatherproof but with some deterioration evident	
COMMENTS: Concrete; wood	
COMPONENT: Roofing	RATING: 3 x WEIGHT: 10.4 = SCORE: 31.3
Some deterioration is evident in membrane and flashings; maintenance or minor repair is needed	
COMMENTS: Hypalon single-ply; standing seam metal

Secondary Systems			
COMPONENT:	Floor Finishes	RATING: 3 x WEIGHT: 6.3 =	SCORE: 18.8
Some wear and minor imperfections are evident; beginning deterioration			
COMMENTS:	Carpet; vinyl tile; ceramic tile; sheet flooring		
COMPONENT:	Wall Finishes	RATING: 3 x WEIGHT: 6.3 =	SCORE: 18.8
Aging surfaces but sound; some maintenance is required			
COMMENTS:	Gypsum board; ceramic tile		
COMPONENT:	Ceiling Finishes	RATING: 3 x WEIGHT: 6.3 =	SCORE: 18.8
Some wear and tear; Minor staining or deterioration			
COMMENTS:	Direct adhered tile; lay-in tile; wood		
COMPONENT:	Doors & Hardware	RATING: 1 x WEIGHT: 6.3 =	SCORE: 6.3
Appropriate hardware, closers, panic devices; in good working order			
COMMENTS:	Interior wood doors w HM frames; exterior aluminum doors/frames

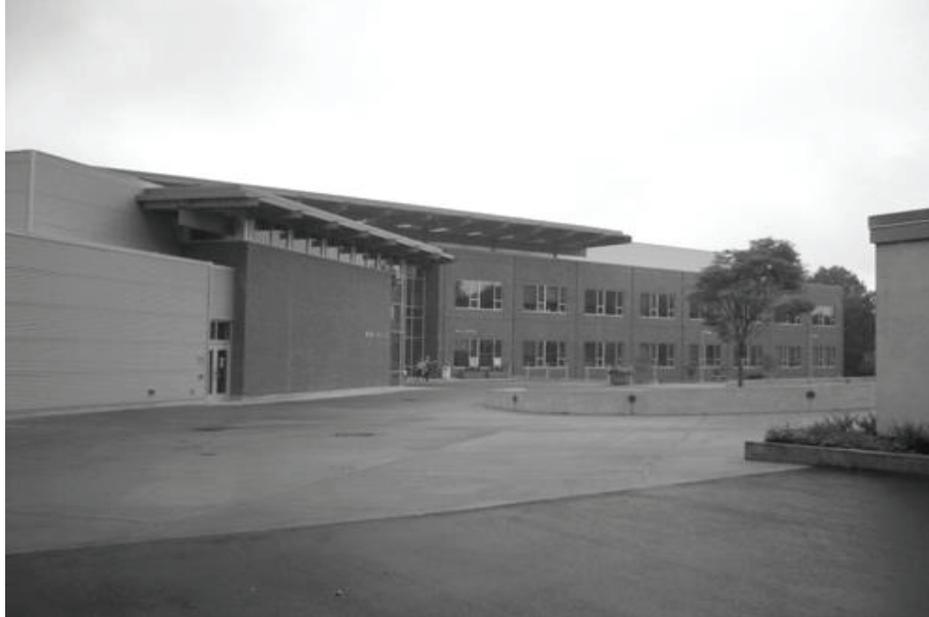
Manspeaker Instructional (020-20) STATE UFI: A04686 Main Campus (020A)
 AREA: 71,755 SF BUILT: 2007 REMODELED: No PREDOMINANT USE: General Classroom
 CONSTRUCTION TYPE: Heavy CRV/SF: \$301 REPLACEMENT VALUE: \$21,598,255

Primary Systems	
COMPONENT: Structure	RATING: 1 x WEIGHT: 8 = SCORE: 8
No signs of settlement or cracking, no abrupt vertical changes Columns, bearing walls and roof structure appears sound/free of defects	
COMMENTS: Steel frame; cast concrete	
COMPONENT: Exterior Closure	RATING: 1 x WEIGHT: 8 = SCORE: 8
Weatherproof, tight, well-maintained exterior walls, doors, windows/finishes	
COMMENTS: Aluminum window walls; concrete; brick; metal wall panels; T&G car decking	
COMPONENT: Roofing	RATING: 1 x WEIGHT: 10 = SCORE: 10
Flashing and penetrations appear sound and membrane appears water- tight; drainage is positive and there are overflow scuppers	
COMMENTS: Single-ply TPO membrane

Secondary Systems			
COMPONENT:	Floor Finishes	RATING: 3 x	WEIGHT: 6 = SCORE: 18
Some wear and minor imperfections are evident; beginning deterioration			
COMMENTS:	Polished concrete; carpet-random staining; ceramic tile; 2x4 end-grain wood		
COMPONENT:	Wall Finishes	RATING: 1 x	WEIGHT: 6 = SCORE: 6
Maintainable surfaces in good condition			
COMMENTS:	Gypsum board; bare concrete; ceramic tile; acoustical panels; wood panels		
COMPONENT:	Ceiling Finishes	RATING: 1 x	WEIGHT: 6 = SCORE: 6
Maintainable surfaces in good condition; good alignment and appearance			
COMMENTS:	Open mesh and solid panel lay-in tile; gypsum board		
COMPONENT:	Doors & Hardware	RATING: 1 x	WEIGHT: 6 = SCORE: 6
Appropriate hardware, closers, panic devices; in good working order			
COMMENTS:	Interior wood doors w HM frames; sidelites; exterior aluminum doors/frames

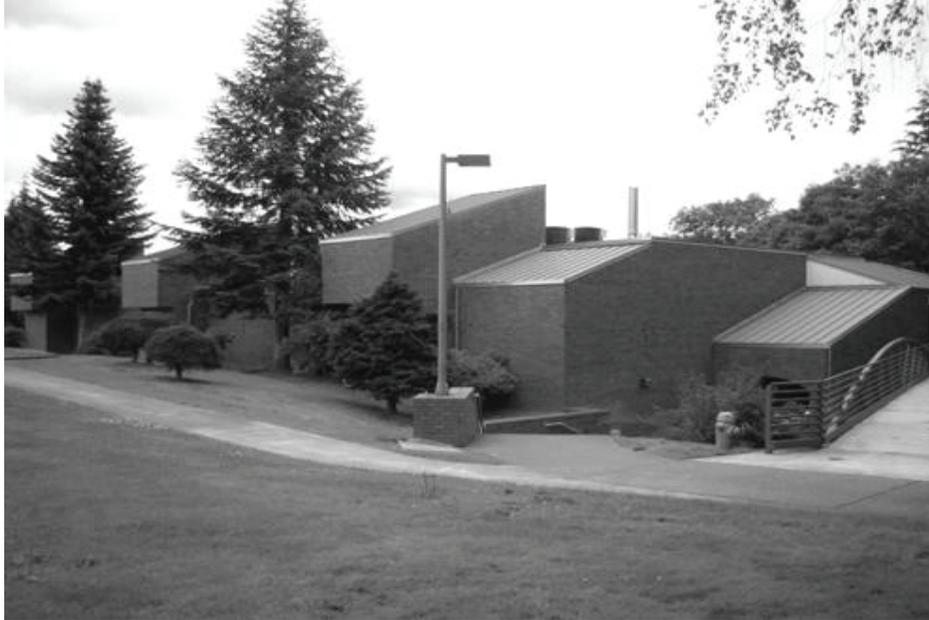
Physci (020-8) STATE UFI: A05609 Main Campus (020A)
 AREA: 18,238 SF BUILT: 1971 REMODELED: No PREDOMINANT USE: Science Lab.
 CONSTRUCTION TYPE: Heavy CRV/SF: \$391 REPLACEMENT VALUE: \$7,131,058

Primary Systems	
COMPONENT: Structure	RATING: 1 x WEIGHT: 8 = SCORE: 8
No signs of settlement or cracking, no abrupt vertical changes Columns, bearing walls and roof structure appears sound/free of defects	
COMMENTS: Concrete; CMU; wood framing	
COMPONENT: Exterior Closure	RATING: 3 x WEIGHT: 8 = SCORE: 24
Sound and weatherproof but with some deterioration evident	
COMMENTS: Concrete; CMU; brick-random deterioration; plaster	
COMPONENT: Roofing	RATING: 3 x WEIGHT: 10 = SCORE: 30
Some deterioration is evident in membrane and flashings; maintenance or minor repair is needed	
COMMENTS: Hypalon single-ply membrane 2010; metal panels 1971

Secondary Systems			
COMPONENT:	Floor Finishes	RATING: 3 x WEIGHT: 6 =	SCORE: 18
	Some wear and minor imperfections are evident; beginning deterioration		
COMMENTS:	Ceramic tile; vinyl tile and carpet-surface wear; concrete		
COMPONENT:	Wall Finishes	RATING: 1 x WEIGHT: 6 =	SCORE: 6
	Maintainable surfaces in good condition		
COMMENTS:	Gypsum board; CMU; ceramic tile; wood strips; wood panels		
COMPONENT:	Ceiling Finishes	RATING: 1 x WEIGHT: 6 =	SCORE: 6
	Maintainable surfaces in good condition; good alignment and appearance		
COMMENTS:	Lay-in tile-tile-grid deterioration in labs 2013; direct adhered tile; exposed concrete structure		
COMPONENT:	Doors & Hardware	RATING: 3 x WEIGHT: 6 =	SCORE: 18
	Functional but dated		
COMMENTS:	Interior wood doors w HM frames; exterior aluminum doors/frames-surface wear

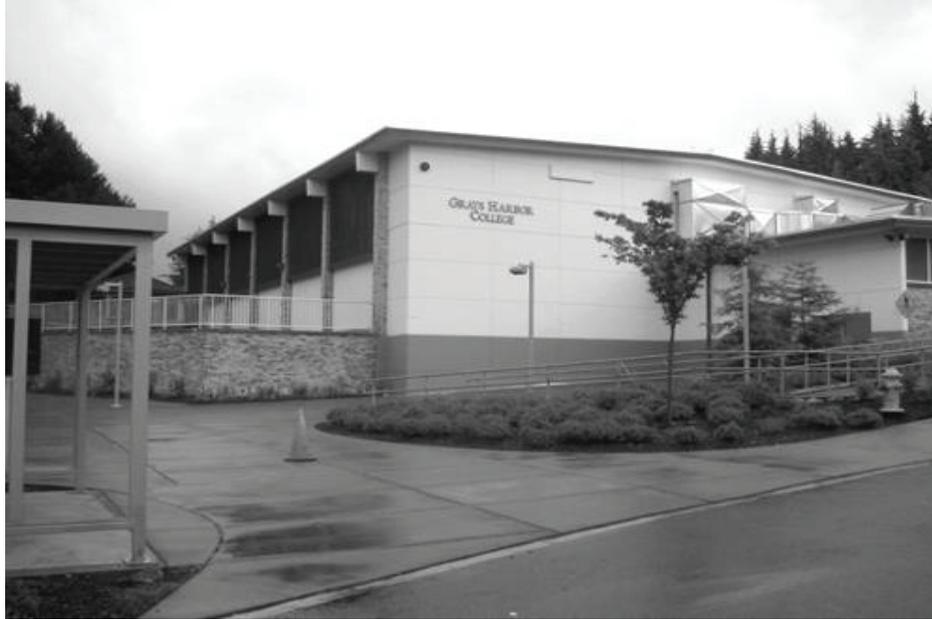
Physed (020-5) STATE UFI: A02269 Main Campus (020A)
 AREA: 18,814 SF BUILT: 1957 REMODELED: 2001 PREDOMINANT USE: Gymnasium
 CONSTRUCTION TYPE: Medium CRV/SF: \$279 REPLACEMENT VALUE: \$5,249,106

Primary Systems	
COMPONENT: Structure	RATING: 3 x WEIGHT: 8.3 = SCORE: 25
Some cracking evident but does not likely affect structural integrity; Visible defects apparent but are non-structural	
COMMENTS: Cast concrete; wood framing	
COMPONENT: Exterior Closure	RATING: 3 x WEIGHT: 8.3 = SCORE: 25
Sound and weatherproof but with some deterioration evident	
COMMENTS: Concrete; dryvit; brick	
COMPONENT: Roofing	RATING: 1 x WEIGHT: 10.4 = SCORE: 10.4
Flashing and penetrations appear sound and membrane appears water-tight; drainage is positive and there are overflow scuppers	
COMMENTS: TPO single-ply membrane-2010

Secondary Systems			
COMPONENT:	Floor Finishes	RATING: 3 x WEIGHT: 6.3 =	SCORE: 18.8
Some wear and minor imperfections are evident; beginning deterioration			
COMMENTS:	Hardwood; concrete; vinyl tile-surface wear; ceramic tile; sheet vinyl; carpet-surface wear		
COMPONENT:	Wall Finishes	RATING: 3 x WEIGHT: 6.3 =	SCORE: 18.8
Aging surfaces but sound; some maintenance is required			
COMMENTS:	Concrete; gypsum board; ceramic tile; CMU		
COMPONENT:	Ceiling Finishes	RATING: 3 x WEIGHT: 6.3 =	SCORE: 18.8
Some wear and tear; Minor staining or deterioration			
COMMENTS:	Tectum panels; direct adhered tile		
COMPONENT:	Doors & Hardware	RATING: 3 x WEIGHT: 6.3 =	SCORE: 18.8
Functional but dated			
COMMENTS:	Interior wood/HM doors w HM frames-surface wear; exterior HM doors/frames
