Grays Harbor College

2018 Facility Master Plan

March 2018

KMB architects

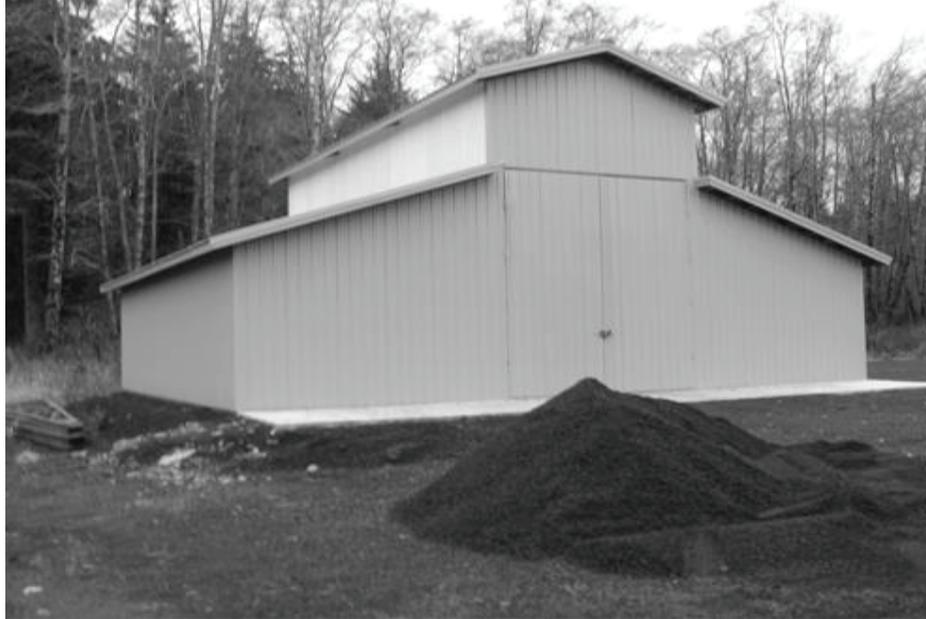
Sand Shed (020-27) STATE UFI: A03359 Main Campus (020A)
 AREA: 1,945 SF BUILT: 2010 REMODELED: No PREDOMINANT USE: Storage
 CONSTRUCTION TYPE: Light CRV/SF: \$43 REPLACEMENT VALUE: \$83,635

Primary Systems		
COMPONENT:	Structure	RATING: 1 x WEIGHT: 9.9 = SCORE: 9.9
No signs of settlement or cracking, no abrupt vertical changes Columns, bearing walls and roof structure appears sound/free of defects		
COMMENTS:	Wood framing	
COMPONENT:	Exterior Closure	RATING: 1 x WEIGHT: 9.9 = SCORE: 9.9
Weatherproof, tight, well-maintained exterior walls, doors, windows/finishes		
COMMENTS:	Metal panels	
COMPONENT:	Roofing	RATING: 1 x WEIGHT: 12.4 = SCORE: 12.4
Flashing and penetrations appear sound and membrane appears water- tight; drainage is positive and there are overflow scuppers		
COMMENTS:	Metal panels

Secondary Systems		
COMPONENT:	Floor Finishes	RATING: 1 x WEIGHT: 7.4 = SCORE: 7.4
Nice appearance, smooth transitions, level subfloors, no cracks/separating		
COMMENTS:	Concrete	
COMPONENT:	Wall Finishes	RATING: 1 x WEIGHT: 7.4 = SCORE: 7.4
Maintainable surfaces in good condition		
COMMENTS:	Metal panels	
COMPONENT:	Ceiling Finishes	RATING: 1 x WEIGHT: 7.4 = SCORE: 7.4
Maintainable surfaces in good condition; good alignment and appearance		
COMMENTS:	Metal panels	
COMPONENT:	Doors & Hardware	RATING: 1 x WEIGHT: 7.4 = SCORE: 7.4
Appropriate hardware, closers, panic devices; in good working order		
COMMENTS:	Metal panel doors

Safety Systems			
COMPONENT:	Life/Safety	RATING: 3 x WEIGHT: 12.4 =	SCORE: 37.1
Generally meets codes for vintage of construction			
COMMENTS:			
COMPONENT:	Fire Safety	RATING: 5 x WEIGHT: 12.4 =	SCORE: 61.9
Violations exist; No exit signs or extinguishers; No sprinklers in high hazard areas			
COMMENTS:			
COMPONENT:	Modifications	RATING: 1 x WEIGHT: 8.7 =	SCORE: 8.7
Modifications appear to be in compliance with codes and sound construction practices; HVAC/electrical service properly provided			
COMMENTS: New

Quality Standards			
COMPONENT:	Maintenance	RATING: 1 x WEIGHT: 8.7 =	SCORE: 8.7
Facility appears well maintained			
COMMENTS:			
COMPONENT:	Remaining Life	RATING: 1 x WEIGHT: 7.4 =	SCORE: 7.4
Life expectancy is >15 years; minor system deterioration			
COMMENTS:			
COMPONENT:	Appearance	RATING: 3 x WEIGHT: 7.4 =	SCORE: 22.3
Average construction; average interior and exterior appearance			
COMMENTS: Average looking simple storage building

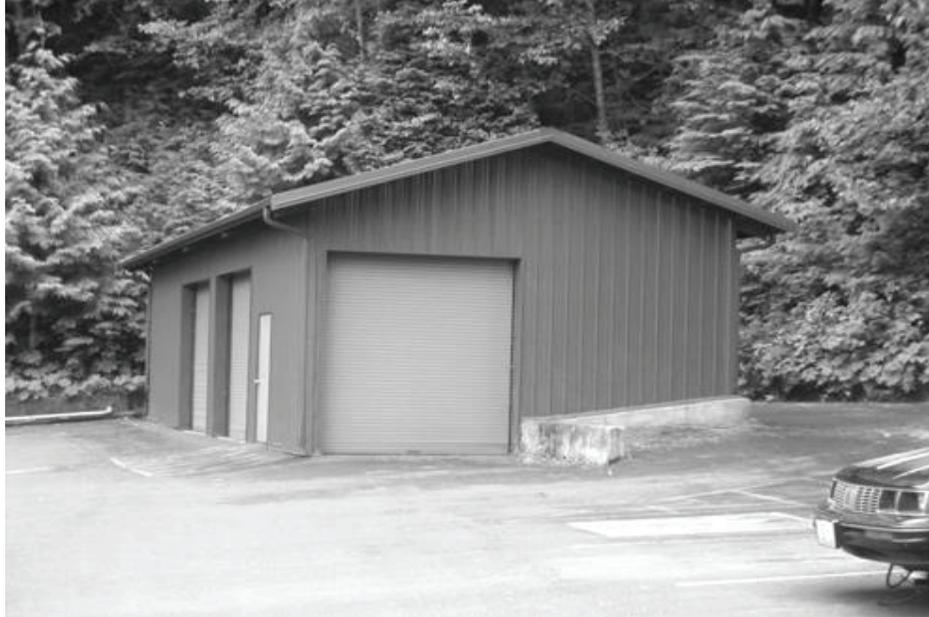
Vocational Storage (020-23) STATE UFI: A07195 Main Campus (020A)
 AREA: 960 SF BUILT: 1997 REMODELED: No PREDOMINANT USE: Storage
 CONSTRUCTION TYPE: Light CRV/SF: \$185 REPLACEMENT VALUE: \$177,600

Primary Systems	
COMPONENT: Structure	RATING: 1 x WEIGHT: 9.9 = SCORE: 9.9
No signs of settlement or cracking, no abrupt vertical changes Columns, bearing walls and roof structure appears sound/free of defects	
COMMENTS:	Wood framing; concrete slab
COMPONENT: Exterior Closure	RATING: 1 x WEIGHT: 9.9 = SCORE: 9.9
Weatherproof, tight, well-maintained exterior walls, doors, windows/finishes	
COMMENTS:	Metal wall panels
COMPONENT: Roofing	RATING: 1 x WEIGHT: 12.4 = SCORE: 12.4
Flashing and penetrations appear sound and membrane appears water- tight; drainage is positive and there are overflow scuppers	
COMMENTS:	Metal roof

Secondary Systems			
COMPONENT:	Floor Finishes	RATING: 1 x WEIGHT: 7.4 =	SCORE: 7.4
Nice appearance, smooth transitions, level subfloors, no cracks/separating			
COMMENTS:	Concrete		
COMPONENT:	Wall Finishes	RATING: 1 x WEIGHT: 7.4 =	SCORE: 7.4
Maintainable surfaces in good condition			
COMMENTS:	Metal wall panels		
COMPONENT:	Ceiling Finishes	RATING: 1 x WEIGHT: 7.4 =	SCORE: 7.4
Maintainable surfaces in good condition; good alignment and appearance			
COMMENTS:	Metal panels		
COMPONENT:	Doors & Hardware	RATING: 3 x WEIGHT: 7.4 =	SCORE: 22.3
Functional but dated			
COMMENTS:	Exterior HM doors/frames-surface wear; metal OH doors-surface wear

Safety Systems			
COMPONENT:	Life/Safety	RATING: 3 x WEIGHT: 12.4 =	SCORE: 37.1
Generally meets codes for vintage of construction			
COMMENTS:			
COMPONENT:	Fire Safety	RATING: 5 x WEIGHT: 12.4 =	SCORE: 61.9
Violations exist; No exit signs or extinguishers; No sprinklers in high hazard areas			
COMMENTS:			
COMPONENT:	Modifications	RATING: 1 x WEIGHT: 8.7 =	SCORE: 8.7
Modifications appear to be in compliance with codes and sound construction practices; HVAC/electrical service properly provided			
COMMENTS: None evident

Quality Standards			
COMPONENT:	Maintenance	RATING: 1 x WEIGHT: 8.7 =	SCORE: 8.7
Facility appears well maintained			
COMMENTS:			
COMPONENT:	Remaining Life	RATING: 3 x WEIGHT: 7.4 =	SCORE: 22.3
Life expectancy is 5-15 years; moderate system deterioration			
COMMENTS:			
COMPONENT:	Appearance	RATING: 3 x WEIGHT: 7.4 =	SCORE: 22.3
Average construction; average interior and exterior appearance			
COMMENTS: Plain vanilla engineered building

TOTAL SCORE = 280 PREVIOUS BIENNIUM SCORE = 254
 CONDITION: Needs Improvement/Additional Maintenance

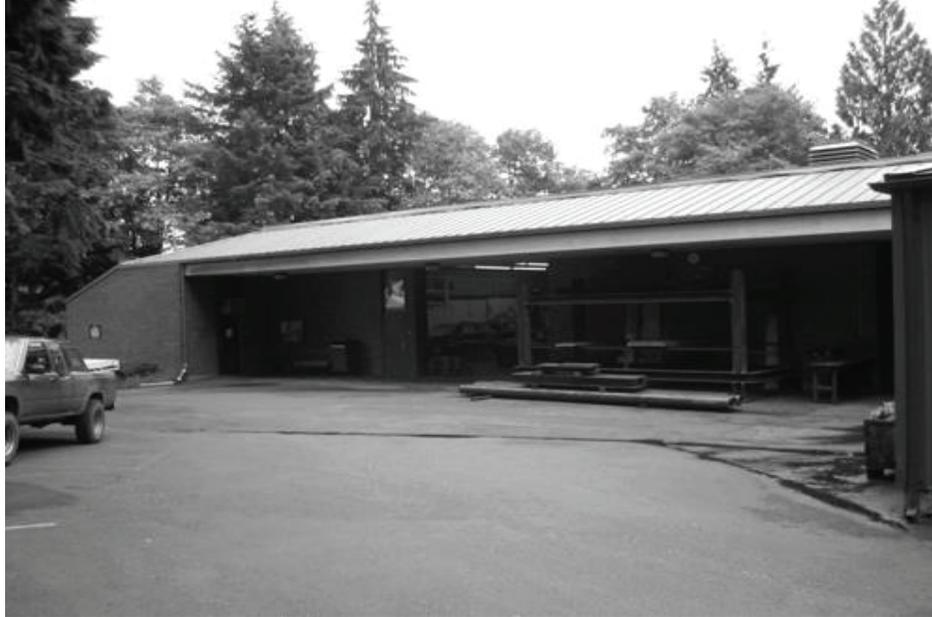
Voktek (020-7) STATE UFI: A09725 Main Campus (020A)
 AREA: 23,305 SF BUILT: 1971 REMODELED: 2010 PREDOMINANT USE: Vocational Arts
 CONSTRUCTION TYPE: Medium CRV/SF: \$316 REPLACEMENT VALUE: \$7,364,380

Primary Systems	
COMPONENT: Structure	RATING: 1 x WEIGHT: 8 = SCORE: 8
No signs of settlement or cracking, no abrupt vertical changes Columns, bearing walls and roof structure appears sound/free of defects	
COMMENTS: Concrete; CMU; wood framing; glu-lam beams	
COMPONENT: Exterior Closure	RATING: 1 x WEIGHT: 8 = SCORE: 8
Weatherproof, tight, well-maintained exterior walls, doors, windows/finishes	
COMMENTS: CMU; concrete; brick; metal panels; plaster soffits	
COMPONENT: Roofing	RATING: 1 x WEIGHT: 10 = SCORE: 10
Flashing and penetrations appear sound and membrane appears water- tight; drainage is positive and there are overflow scuppers	
COMMENTS: Standing seam metal; hypalon single-ply membrane-2008

Secondary Systems		
COMPONENT:	Floor Finishes	RATING: 1 x WEIGHT: 6 = SCORE: 6
Nice appearance, smooth transitions, level subfloors, no cracks/separating		
COMMENTS:	Concrete; vinyl tile; ceramic tile; carpet	
COMPONENT:	Wall Finishes	RATING: 1 x WEIGHT: 6 = SCORE: 6
Maintainable surfaces in good condition		
COMMENTS:	CMU; gypsum board	
COMPONENT:	Ceiling Finishes	RATING: 1 x WEIGHT: 6 = SCORE: 6
Maintainable surfaces in good condition; good alignment and appearance		
COMMENTS:	Gypsum board; wood roof deck; direct adhered tile	
COMPONENT:	Doors & Hardware	RATING: 1 x WEIGHT: 6 = SCORE: 6
Appropriate hardware, closers, panic devices; in good working order		
COMMENTS:	Interior wood/HM doors w HM frames; exterior HM doors/frames; metal OH and coiling doors

Service Systems		
COMPONENT:	Elevators	RATING: 3 x WEIGHT: 6 = SCORE: 18
Elevators provided but functionality is inadequate; Unreliable operation		
COMMENTS:	No elevator to lower area	
COMPONENT:	Plumbing	RATING: 3 x WEIGHT: 8 = SCORE: 24
Fixtures are functional but dated; some leaks; maintenance required		
COMMENTS:	Galvanized, cast iron, copper and steel piping; porcelain fixtures	
COMPONENT:	HVAC	RATING: 3 x WEIGHT: 8 = SCORE: 24
System generally adequate; some deterioration; needs balancing; Offices areas have A/C; hazardous areas are ventilated		
COMMENTS:	AHUs (2013) with electric strip heat; duct heaters; ceiling furnaces	
COMPONENT:	Electrical	RATING: 1 x WEIGHT: 8 = SCORE: 8
Adequate service and distribution capacity for current/future needs		
COMMENTS:	1600amp 480/277v; 1200amp 208/120v	
COMPONENT:	Lights/Power	RATING: 1 x WEIGHT: 8 = SCORE: 8
Contemporary lighting with good work area illumination; ample outlets

Safety Systems			
COMPONENT:	Life/Safety	RATING: 3 x	WEIGHT: 10 = SCORE: 30
Generally meets codes for vintage of construction			
COMMENTS:			
COMPONENT:	Fire Safety	RATING: 1 x	WEIGHT: 10 = SCORE: 10
Locally monitored detection; alarm present; sprinklers in high hazard areas			
COMMENTS: Partial sprinklers			
COMPONENT:	Modifications	RATING: 1 x	WEIGHT: 7 = SCORE: 7
Modifications appear to be in compliance with codes and sound construction practices; HVAC/electrical service properly provided			
COMMENTS: Upper floor renovation and minor lower floor remodel were well executed

Quality Standards			
COMPONENT:	Maintenance	RATING: 1 x	WEIGHT: 7 = SCORE: 7
Facility appears well maintained			
COMMENTS:			
COMPONENT:	Remaining Life	RATING: 1 x	WEIGHT: 6 = SCORE: 6
Life expectancy is >15 years; minor system deterioration			
COMMENTS: 2010 upper floor renovation has greatly enhanced building and extended useful life			
COMPONENT:	Appearance	RATING: 3 x	WEIGHT: 6 = SCORE: 18
Average construction; average interior and exterior appearance			
COMMENTS: Very utilitarian exterior

TOTAL SCORE = 246 PREVIOUS BIENNIUM SCORE = 246
 CONDITION: Adequate

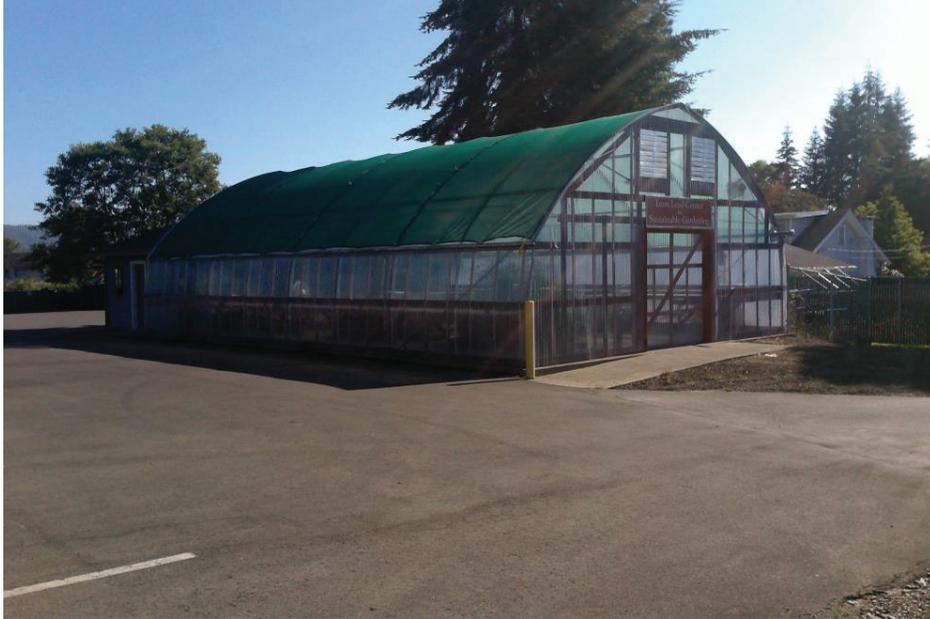
Leon Lead Rec Greenhouse (020-22G) STATE UFI: A05541 Riverview Ed. Center (020C)
 AREA: 1,824 SF BUILT: 2009 REMODELED: No data PREDOMINANT USE: Classroom
 CONSTRUCTION TYPE: No data CRV/SF: \$285 REPLACEMENT VALUE: \$519,840

Primary Systems	
COMPONENT: Structure	RATING: 1 x WEIGHT: 10.2 = SCORE: 10.2
No signs of settlement or cracking, no abrupt vertical changes Columns, bearing walls and roof structure appears sound/free of defects	
COMMENTS: No Comments	
COMPONENT: Exterior Closure	RATING: 1 x WEIGHT: 10.2 = SCORE: 10.2
Weatherproof, tight, well-maintained exterior walls, doors, windows/finishes	
COMMENTS: No data	
COMPONENT: Roofing	RATING: 3 x WEIGHT: 12.7 = SCORE: 38.1
Some deterioration is evident in membrane and flashings; maintenance or minor repair is needed	
COMMENTS: plastic panels

Secondary Systems		
COMPONENT:	Floor Finishes	RATING: 3 x WEIGHT: 7.6 = SCORE: 22.9
Some wear and minor imperfections are evident; beginning deterioration		
COMMENTS:	concrete, gravel	
COMPONENT:	Wall Finishes	RATING: 3 x WEIGHT: 7.6 = SCORE: 22.9
Aging surfaces but sound; some maintenance is required		
COMMENTS:	Drywall in shed	
COMPONENT:	Ceiling Finishes	RATING: 0 x WEIGHT: 0 = SCORE: 0
No data		
COMMENTS:	None	
COMPONENT:	Doors & Hardware	RATING: 3 x WEIGHT: 7.6 = SCORE: 22.9
Functional but dated		
COMMENTS:	No data

Service Systems		
COMPONENT:	Elevators	RATING: 0 x WEIGHT: 0 = SCORE: 0
No data		
COMMENTS:	No data	
COMPONENT:	Plumbing	RATING: 1 x WEIGHT: 10.2 = SCORE: 10.2
Fixtures and piping appear to be in good condition; no evidence of leaks		
COMMENTS:	No data	
COMPONENT:	HVAC	RATING: 3 x WEIGHT: 10.2 = SCORE: 30.5
System generally adequate; some deterioration; needs balancing; Offices areas have A/C; hazardous areas are ventilated		
COMMENTS:	No data	
COMPONENT:	Electrical	RATING: 1 x WEIGHT: 10.2 = SCORE: 10.2
Adequate service and distribution capacity for current/future needs		
COMMENTS:	No data	
COMPONENT:	Lights/Power	RATING: 3 x WEIGHT: 10.2 = SCORE: 30.5
Adequate work area illumination; adequate outlets for current use		
COMMENTS:	No data

Safety Systems		
COMPONENT:	Life/Safety	RATING: 3 x WEIGHT: 12.7 = SCORE: 38.1
Generally meets codes for vintage of construction		
COMMENTS:	No data	
COMPONENT:	Fire Safety	RATING: 3 x WEIGHT: 12.7 = SCORE: 38.1
Extinguishers and signed egress; no violations; no alarm or sprinklers		
COMMENTS:	No data	
COMPONENT:	Modifications	RATING: 0 x WEIGHT: 0 = SCORE: 0
No data		
COMMENTS:	No data

Quality Standards		
COMPONENT:	Maintenance	RATING: 1 x WEIGHT: 8.9 = SCORE: 8.9
Facility appears well maintained		
COMMENTS:	No data	
COMPONENT:	Remaining Life	RATING: 1 x WEIGHT: 7.6 = SCORE: 7.6
Life expectancy is >15 years; minor system deterioration		
COMMENTS:	No data	
COMPONENT:	Appearance	RATING: 3 x WEIGHT: 7.6 = SCORE: 22.9
Average construction; average interior and exterior appearance		
COMMENTS:	No data

CONDITION: Needs Improvement/Additional Maintenance

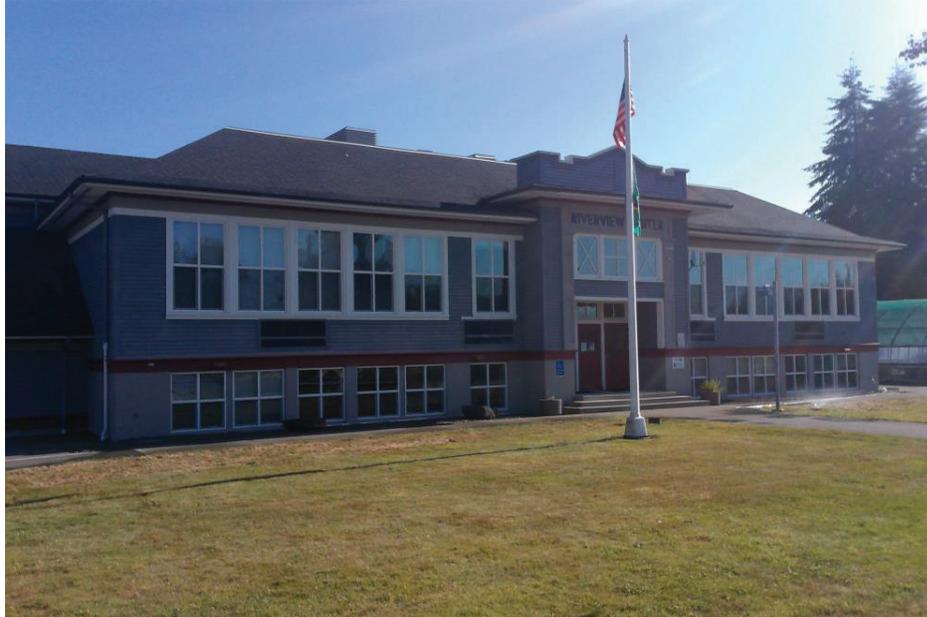
Riverview Education Ctr (020-22) STATE UFI: A04555 Riverview Ed. Center (020C)
 AREA: 12,660 SF BUILT: 1925 REMODELED: 2001 PREDOMINANT USE: General Classroom
 CONSTRUCTION TYPE: Medium CRV/SF: \$301 REPLACEMENT VALUE: \$3,810,660

Primary Systems	
COMPONENT: Structure	RATING: 1 x WEIGHT: 8 = SCORE: 8
No signs of settlement or cracking, no abrupt vertical changes Columns, bearing walls and roof structure appears sound/free of defects	
COMMENTS: Concrete; wood framing	
COMPONENT: Exterior Closure	RATING: 3 x WEIGHT: 8 = SCORE: 24
Sound and weatherproof but with some deterioration evident	
COMMENTS: Wood horizontal beveled siding-mix of original and new; concrete. Needs paint.	
COMPONENT: Roofing	RATING: 1 x WEIGHT: 10 = SCORE: 10
Flashing and penetrations appear sound and membrane appears water- tight; drainage is positive and there are overflow scuppers	
COMMENTS: Composition 3-tab shingles-2001; TPO single ply membrane-2007

Secondary Systems			
COMPONENT:	Floor Finishes	RATING: 1 x WEIGHT: 6 =	SCORE: 6
Nice appearance, smooth transitions, level subfloors, no cracks/separating			
COMMENTS:	Carpet, vinyl tile and sheet flooring		
COMPONENT:	Wall Finishes	RATING: 1 x WEIGHT: 6 =	SCORE: 6
Maintainable surfaces in good condition			
COMMENTS:	Gypsum board and vinyl wall panels		
COMPONENT:	Ceiling Finishes	RATING: 1 x WEIGHT: 6 =	SCORE: 6
Maintainable surfaces in good condition; good alignment and appearance			
COMMENTS:	Direct adhered tile; lay-in tile; gypsum board		
COMPONENT:	Doors & Hardware	RATING: 1 x WEIGHT: 6 =	SCORE: 6
Appropriate hardware, closers, panic devices; in good working order			
COMMENTS:	Interior wood/HM doors/frames-surface wear; exterior aluminum/wood doors/frames

Service Systems			
COMPONENT:	Elevators	RATING: 1 x WEIGHT: 6 =	SCORE: 6
Appropriate and functional for occupancy and use			
COMMENTS:	2 stop		
COMPONENT:	Plumbing	RATING: 1 x WEIGHT: 8 =	SCORE: 8
Fixtures and piping appear to be in good condition; no evidence of leaks			
COMMENTS:	Copper, cast iron, steel and PVC piping; porcelain fixtures		
COMPONENT:	HVAC	RATING: 3 x WEIGHT: 8 =	SCORE: 24
System generally adequate; some deterioration; needs balancing; Offices areas have A/C; hazardous areas are ventilated			
COMMENTS:	Roof mount packaged HVAC units; classroom univent units		
COMPONENT:	Electrical	RATING: 1 x WEIGHT: 8 =	SCORE: 8
Adequate service and distribution capacity for current/future needs			
COMMENTS:	800amp 208/120v		
COMPONENT:	Lights/Power	RATING: 1 x WEIGHT: 8 =	SCORE: 8
Contemporary lighting with good work area illumination; ample outlets			
COMMENTS:	Lay-in, suspended and ceiling-mount fluorescent lights

Safety Systems		
COMPONENT:	Life/Safety	RATING: 1 x WEIGHT: 10 = SCORE: 10
Appears to meet current codes		
COMMENTS:		
COMPONENT:	Fire Safety	RATING: 3 x WEIGHT: 10 = SCORE: 30
Extinguishers and signed egress; no violations; no alarm or sprinklers		
COMMENTS:		
COMPONENT:	Modifications	RATING: 1 x WEIGHT: 7 = SCORE: 7
Modifications appear to be in compliance with codes and sound construction practices; HVAC/electrical service properly provided		
COMMENTS:	77 year old building was completely renovated in 2001

Quality Standards		
COMPONENT:	Maintenance	RATING: 1 x WEIGHT: 7 = SCORE: 7
Facility appears well maintained		
COMMENTS:		
COMPONENT:	Remaining Life	RATING: 1 x WEIGHT: 6 = SCORE: 6
Life expectancy is >15 years; minor system deterioration		
COMMENTS:	Comprehensive renovation has upgraded all major building systems	
COMPONENT:	Appearance	RATING: 1 x WEIGHT: 6 = SCORE: 6
Well-constructed building; generally attractive interior and exterior		
COMMENTS:

CONDITION: Adequate

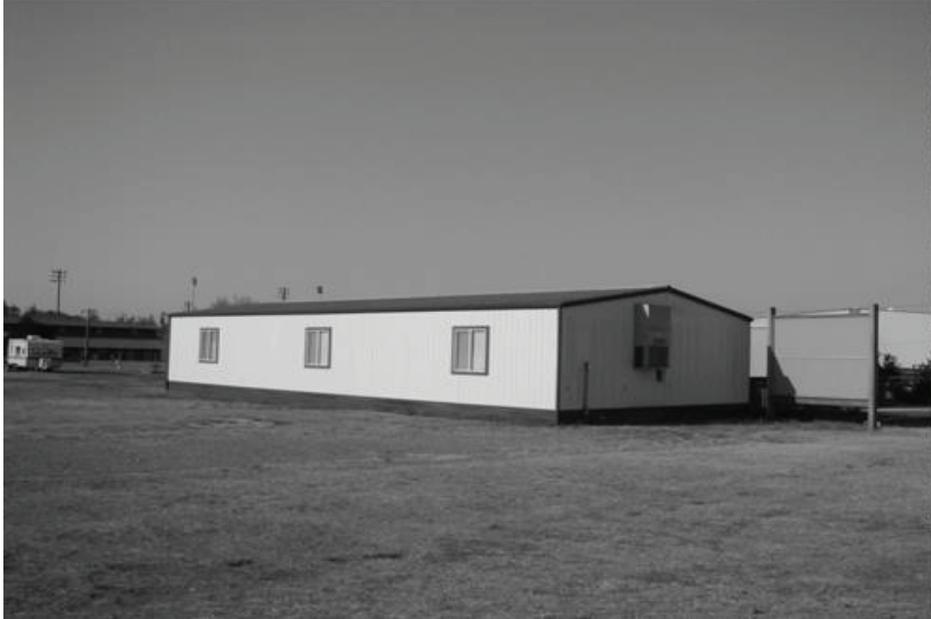
Simpson Education Center (020-24) STATE UFI: A03108 Simpson Ed. Center (020D)
 AREA: 1,792 SF BUILT: 1998 REMODELED: No PREDOMINANT USE: General Classroom
 CONSTRUCTION TYPE: Temporary CRV/SF: \$185 REPLACEMENT VALUE: \$331,520

Primary Systems	
COMPONENT: Structure	RATING: 3 x WEIGHT: 8.5 = SCORE: 25.4
Some cracking evident but does not likely affect structural integrity; Visible defects apparent but are non-structural	
COMMENTS: Wood framing	
COMPONENT: Exterior Closure	RATING: 3 x WEIGHT: 8.5 = SCORE: 25.4
Sound and weatherproof but with some deterioration evident	
COMMENTS: T1-11 plywood	
COMPONENT: Roofing	RATING: 3 x WEIGHT: 10.6 = SCORE: 31.7
Some deterioration is evident in membrane and flashings; maintenance or minor repair is needed	
COMMENTS: Metal roof

Secondary Systems			
COMPONENT:	Floor Finishes	RATING: 3 x WEIGHT: 6.3 =	SCORE: 19
Some wear and minor imperfections are evident; beginning deterioration			
COMMENTS:	Carpet throughout		
COMPONENT:	Wall Finishes	RATING: 1 x WEIGHT: 6.3 =	SCORE: 6.3
Maintainable surfaces in good condition			
COMMENTS:	Vinyl wall panels		
COMPONENT:	Ceiling Finishes	RATING: 3 x WEIGHT: 6.3 =	SCORE: 19
Some wear and tear; Minor staining or deterioration			
COMMENTS:	Lay-in tile throughout		
COMPONENT:	Doors & Hardware	RATING: 3 x WEIGHT: 6.3 =	SCORE: 19
Functional but dated			
COMMENTS:	HM doors and frames

Service Systems			
COMPONENT:	Elevators	RATING: 1 x WEIGHT: 6.3 =	SCORE: 6.3
Appropriate and functional for occupancy and use			
COMMENTS:	None		
COMPONENT:	Plumbing	RATING: 0 x WEIGHT: 0 =	SCORE: 0
No data			
COMMENTS:	None		
COMPONENT:	HVAC	RATING: 3 x WEIGHT: 8.5 =	SCORE: 25.4
System generally adequate; some deterioration; needs balancing; Offices areas have A/C; hazardous areas are ventilated			
COMMENTS:	Newer exterior wall mount packaged HVAC units		
COMPONENT:	Electrical	RATING: 3 x WEIGHT: 8.5 =	SCORE: 25.4
Service capacity meets current needs but inadequate for future			
COMMENTS:	Adequate for space use		
COMPONENT:	Lights/Power	RATING: 1 x WEIGHT: 8.5 =	SCORE: 8.5
Contemporary lighting with good work area illumination; ample outlets			
COMMENTS:	New recessed ceiling fluorescent

Safety Systems			
COMPONENT:	Life/Safety	RATING: 1 x	WEIGHT: 10.6 = SCORE: 10.6
Appears to meet current codes			
COMMENTS:	Generally meets codes		
COMPONENT:	Fire Safety	RATING: 5 x	WEIGHT: 10.6 = SCORE: 52.9
Violations exist; No exit signs or extinguishers; No sprinklers in high hazard areas			
COMMENTS:	No alarm; no sprinklers		
COMPONENT:	Modifications	RATING: 1 x	WEIGHT: 7.4 = SCORE: 7.4
Modifications appear to be in compliance with codes and sound construction practices; HVAC/electrical service properly provided			
COMMENTS:	None evident

Quality Standards			
COMPONENT:	Maintenance	RATING: 1 x	WEIGHT: 7.4 = SCORE: 7.4
Facility appears well maintained			
COMMENTS:	Generally well maintained		
COMPONENT:	Remaining Life	RATING: 5 x	WEIGHT: 6.3 = SCORE: 31.7
Life expectancy is <5 years; significant system deterioration			
COMMENTS:	PORTABLE IS CURRENTLY LEASED TO ANOTHER ENTITY		
COMPONENT:	Appearance	RATING: 3 x	WEIGHT: 6.3 = SCORE: 19
Average construction; average interior and exterior appearance			
COMMENTS:	Average looking interior and exterior

Heat Loss			
COMPONENT:	Insulation	RATING: 3 x	WEIGHT: 6.3 = SCORE: 19
Insulation present, but not to current standards (installed prior to 2010)			
COMMENTS:	Inadequate		
COMPONENT:	Glazing	RATING: 1 x	WEIGHT: 6.3 = SCORE: 6.3
Double glazing with window frames that minimize conductivity			
COMMENTS:	Double glazing; vinyl framed

CONDITION: Needs Improvement/Renovation

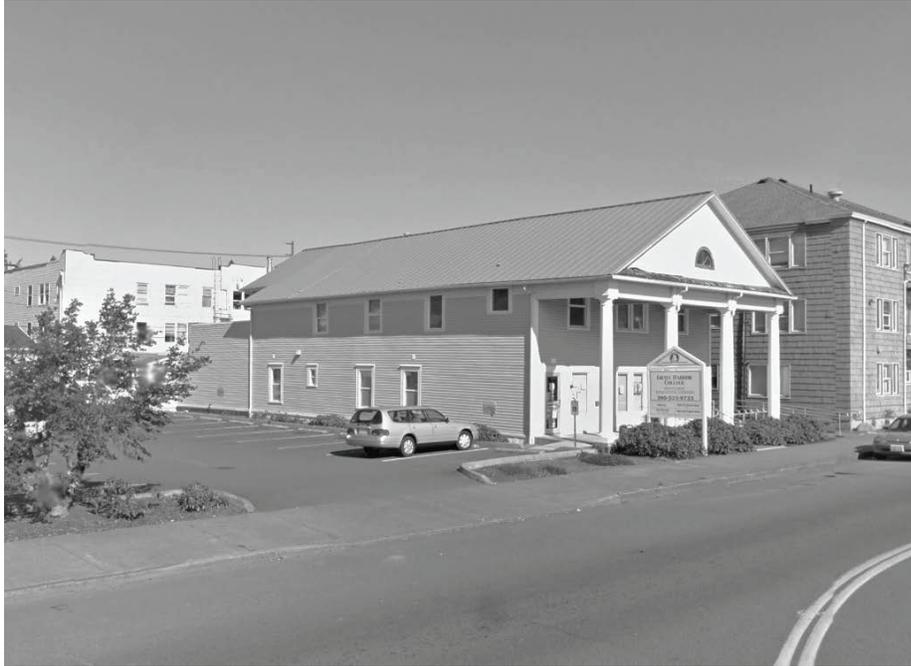
AREA: 5,396 SF BUILT: 1919 REMODELED: 1997 PREDOMINANT USE: Mixed Use
 CONSTRUCTION TYPE: Light CRV/SF: \$316 REPLACEMENT VALUE: \$1,705,136

Primary Systems			
COMPONENT:	Structure	RATING: 3 x	WEIGHT: 8 SCORE: 24
Some cracking evident but does not likely affect structural integrity; Visible defects apparent but are non structural			
COMMENTS:	Wood framing; standing water in crawlspace; slow settling (now stable)		
COMPONENT:	Exterior Closure	RATING: 1 x	WEIGHT: 8 SCORE: 8
Weatherproof, tight, well maintained exterior walls, doors, windows/finishes			
COMMENTS:	Vinyl siding over wood 1997		
COMPONENT:	Roofing	RATING: 3 x	WEIGHT: 10 SCORE: 30
Some deterioration is evident in membrane and flashings; maintenance or minor repair is needed			
COMMENTS:	Standing seam metal 1997; hypalon single ply 1997; BUR wearing

Secondary Systems			
COMPONENT:	Floor Finishes	RATING: 1 x WEIGHT: 6 =	SCORE: 6
	Nice appearance, smooth transitions, level subfloors, no cracks/separating		
COMMENTS:	Carpet and sheet vinyl; some carpet deterioration and staining		
COMPONENT:	Wall Finishes	RATING: 1 x WEIGHT: 6 =	SCORE: 6
	Maintainable surfaces in good condition		
COMMENTS:	Gypsum board and plaster; sheet vinyl wainscot		
COMPONENT:	Ceiling Finishes	RATING: 1 x WEIGHT: 6 =	SCORE: 6
	Maintainable surfaces in good condition; good alignment and appearance		
COMMENTS:	Gypsum board; direct adhered tile; lay-in tile; wood ceilings		
COMPONENT:	Doors & Hardware	RATING: 3 x WEIGHT: 6 =	SCORE: 18
	Functional but dated		
COMMENTS:	Interior wood doors w HM frames-surface wear; exterior HM doors/frames

Service Systems			
COMPONENT:	Elevators	RATING: 1 x WEIGHT: 6 =	SCORE: 6
	Appropriate and functional for occupancy and use		
COMMENTS:	2-stop-1997		
COMPONENT:	Plumbing	RATING: 1 x WEIGHT: 8 =	SCORE: 8
	Fixtures and piping appear to be in good condition; no evidence of leaks		
COMMENTS:	Copper, cast iron, steel and PVC piping; porcelain fixtures		
COMPONENT:	HVAC	RATING: 1 x WEIGHT: 8 =	SCORE: 8
	Equipment in good condition; easily controlled; serves all required spaces; All necessary spaces are adequately ventilated; A/C provided		
COMMENTS:	Roof mount packaged heat pumps-1997		
COMPONENT:	Electrical	RATING: 1 x WEIGHT: 8 =	SCORE: 8
	Adequate service and distribution capacity for current/future needs		
COMMENTS:	200amp 208/120v		
COMPONENT:	Lights/Power	RATING: 1 x WEIGHT: 8 =	SCORE: 8
	Contemporary lighting with good work area illumination; ample outlets		
COMMENTS:	Ceiling mount and lay-in fluorescent lighting

Safety Systems			
COMPONENT:	Life/Safety	RATING: 3 x WEIGHT: 10 =	SCORE: 30
Generally meets codes for vintage of construction			
COMMENTS:			
COMPONENT:	Fire Safety	RATING: 5 x WEIGHT: 10 =	SCORE: 50
Violations exist; No exit signs or extinguishers; No sprinklers in high hazard areas			
COMMENTS:			
COMPONENT:	Modifications	RATING: 1 x WEIGHT: 7 =	SCORE: 7
Modifications appear to be in compliance with codes and sound construction practices; HVAC/electrical service properly provided			
COMMENTS: 1997 major renovation appears adequately constructed

Quality Standards			
COMPONENT:	Maintenance	RATING: 1 x WEIGHT: 7 =	SCORE: 7
Facility appears well maintained			
COMMENTS:			
COMPONENT:	Remaining Life	RATING: 3 x WEIGHT: 6 =	SCORE: 18
Life expectancy is 5-15 years; moderate system deterioration			
COMMENTS: Old building with a face-lift and interior renovation			
COMPONENT:	Appearance	RATING: 1 x WEIGHT: 6 =	SCORE: 6
Well-constructed building; generally attractive interior and exterior			
COMMENTS:

TOTAL SCORE = 278 PREVIOUS BIENNIUM SCORE = 278
 CONDITION: Needs Improvement/Additional Maintenance
